Effects of Fire Damage on the Structural Properties of Steel Bridge Elements

FINAL REPORT

April 30, 2011

University of Pittsburgh

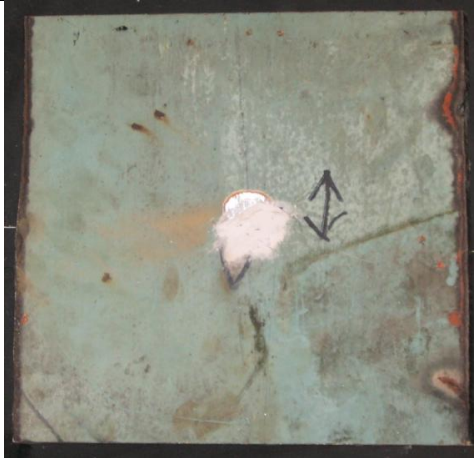
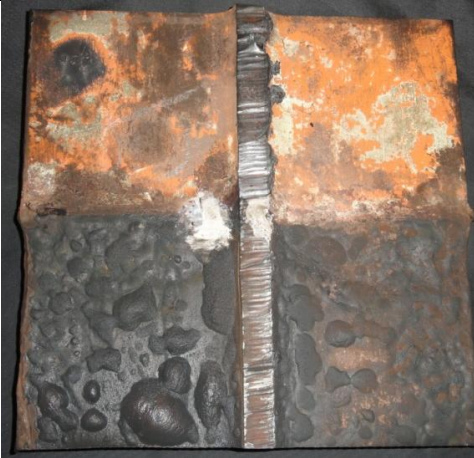
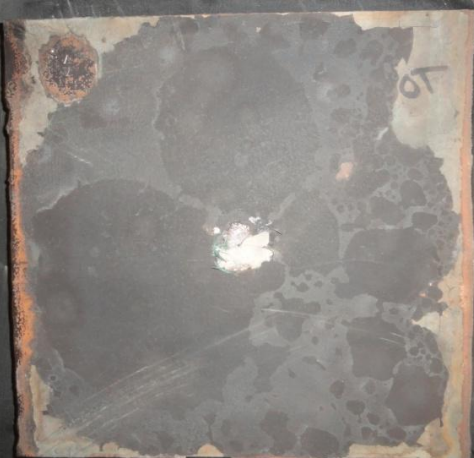
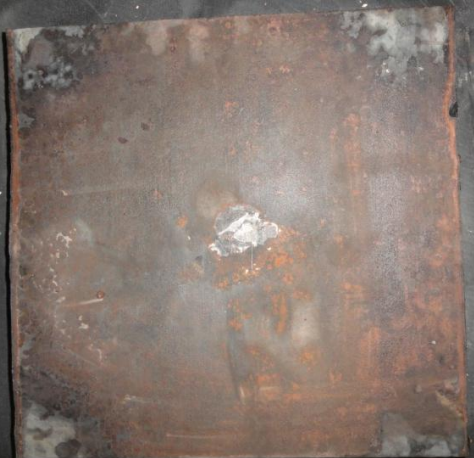
Older steel bridges with indeterminate paint coating systems (Same vintage as steel beams provided by Penn-DOT) (Circa: 1960 – 70)			
Before fire exposure	After fire exposure - 800 °F	After brushing surface	After washing surface

Description:	<i>Non-flame side</i>		
Paint is in reasonable condition. Some scratches, chips, some rust and other typical defects are apparent. (Note: The shiny white patch at plate center was where the paint was scratched off to attach thermocouples)	The plate surface directly exposed to flames will be covered with black soot. Bubbles will be seen in the paint coating on the non-flame side as shown above. Some of these paint bubbles may be cracked, but the material will still be in place.	After hand wire brushing clean, most of the paint will be removed from both the flame and non-flame sides though there may still be some patches of paint. The outline of the bubbles that had formed in the paint may be visible along with discoloration of the plate	After pressure or hand washing clean, all the soot and most of the paint will be removed from both the flame and non-flame sides. Some patches of paint may still be visible.

Material Properties:			
For steel grades with nominal yield stress less than or equal to 50 ksi, fire exposure producing surface conditions as shown above will result in a small (5%) reduction in the material yield strength, ultimate strength, surface hardness, and the CVN fracture toughness. For heat treated steels (e.g., A514, HPS), acquire material samples from the fire-exposed and unexposed portions of the beams. Conduct CVN fracture toughness tests according to ASTM E23 to evaluate the effects of fire on steel.

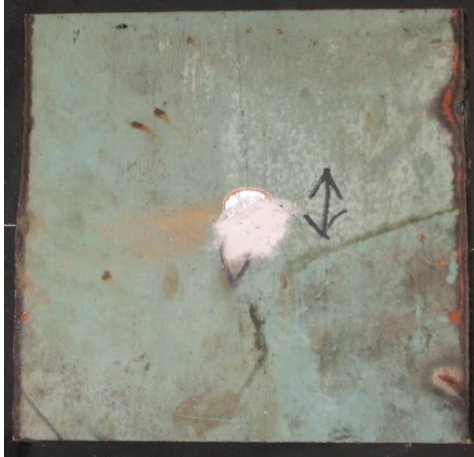
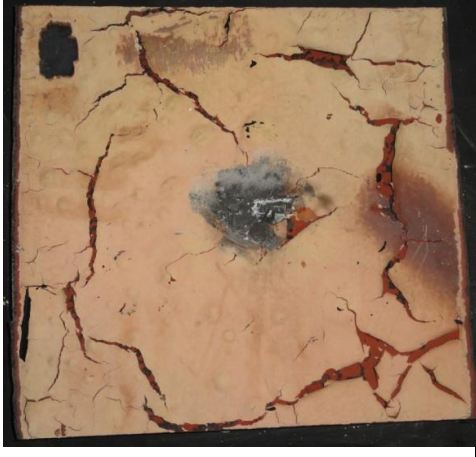
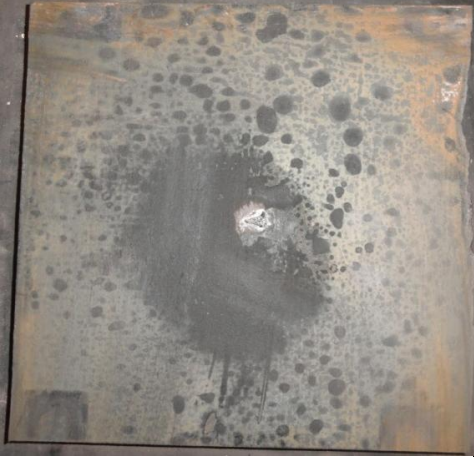
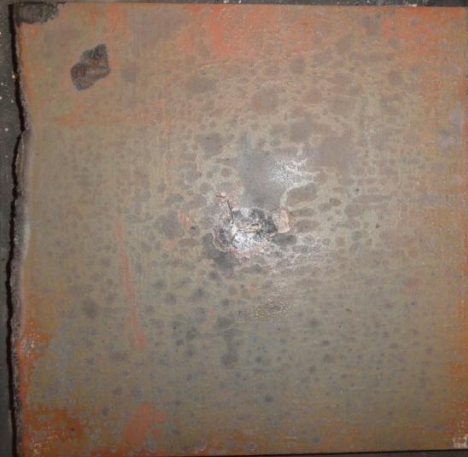
Older steel bridges with indeterminate coating (Same vintage as steel beams provided by Penn-DOT after being exposed to real fire event) (Circa: 1960 – 70)			
Before fire exposure	After fire exposure - 1200 °F	After brushing surface	After washing surface

Description: Paint is in reasonable condition. Some scratches, chips, some rust and other typical defects are apparent. (Note: The shiny white patch at plate center was where the paint was scratched off to attach thermocouples)	<i>Non-Flame Side</i> The plate surface directly exposed to flames will be covered with black soot. The paint coating on the non-flame side will be cracked, but the material will still be in place as shown above.	After hand wire brushing clean, most of the paint will be removed from both the flame and non-flame sides though there may still be some patches of paint. The outline of the bubbles that had formed in the paint may be visible along with discoloration of the plate. Larger discolored rings may be seen where flames came in direct contact with steel surfaces.	After pressure or hand washing, all the soot and most of the paint will be removed from both the flame and non-flame sides. Some patches of paint may still be visible.

Material Properties:			
For steel grades with nominal yield stress less than or equal to 50 ksi, fire exposure producing surface conditions as shown above will result in a small (5%) reduction in the material yield strength, ultimate strength, surface hardness. The influence on the CVN fracture toughness can be more significant (+20 to -40%). Conduct CVN fracture toughness tests on material samples taken from the unexposed steel to evaluate reserve margin with respect to minimum CVN toughness requirements. For heat treated steels (e.g., A514, HPS), acquire material samples from the fire-exposed and unexposed portions of the beams. Conduct CVN fracture toughness tests according to ASTM E23 to evaluate the effects of fire on steel.

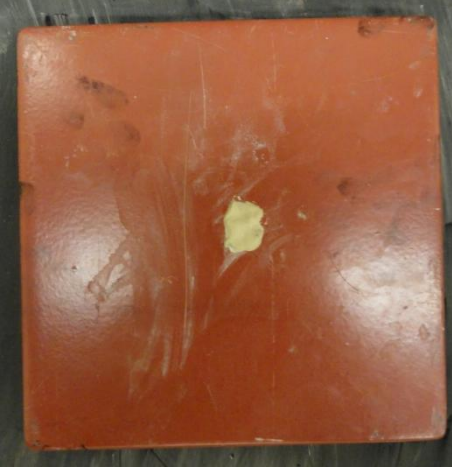
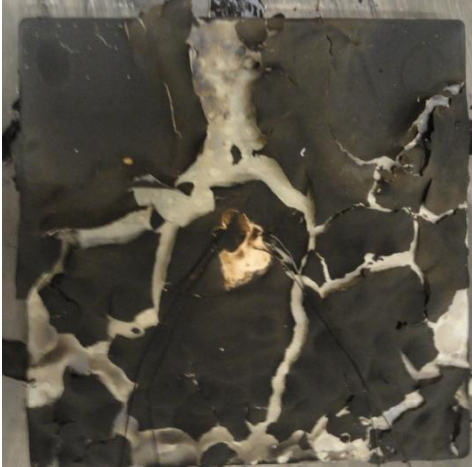
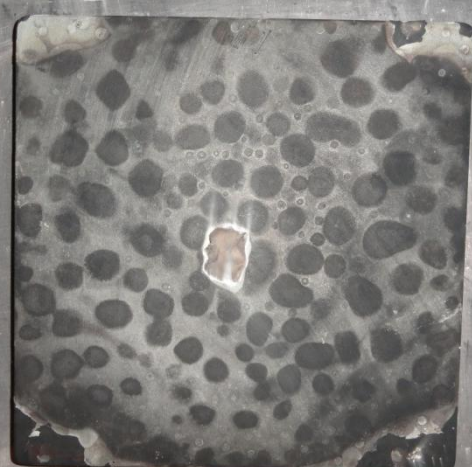
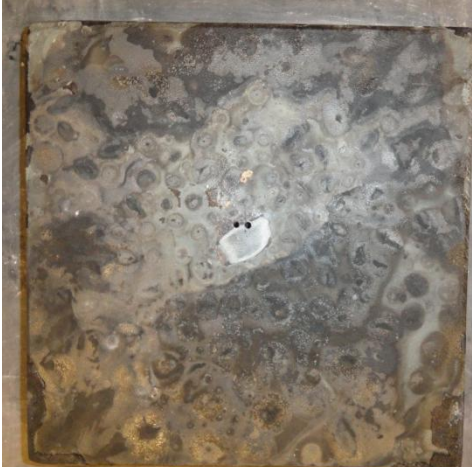
Before fire exposure	After fire exposure	After brushing surface	After washing surface

Description: Paint is in good condition. No significant scratches, chips, rust or other typical defects are apparent. (Note: The shiny white patch at plate center was where the paint was scratched off to attach thermocouples)	<i>Non-Flame Side</i> The plate surface directly exposed to flames will have little soot because the top-coat of the paint will have fallen off (along with the soot) when the temperature exceeded 700 °F. The paint coating on the non-flame side will have bubbled and cracked, but the paint material will still be in place as shown above.	After hand wire brushing clean, most of the top coat will be eliminated from both sides. The base coat will still be intact. The outline of the bubbles that formed in the paint may be visible with discoloration of the plate.	After washing clean, all the soot and most of the top coat of the paint system will be removed from both the flame and non-flame sides. The base coat of the paint system will likely remain still intact over the plate surfaces.

Material Properties: For steel grades with nominal yield stress less than or equal to 50 ksi, fire exposure producing surface conditions as shown above will result in a small (5%) reduction on the material yield strength, ultimate strength, surface hardness. The influence on the CVN fracture toughness can be _____. Conduct CVN fracture toughness tests on material samples taken from the unexposed steel to evaluate reserve margin with respect to minimum CVN toughness requirements. For heat treated steels (e.g., A514, HPS), acquire material samples from the fire-exposed and unexposed portions of the beams. Conduct CVN fracture toughness tests according to ASTM E23 to evaluate the effects of fire on steel.

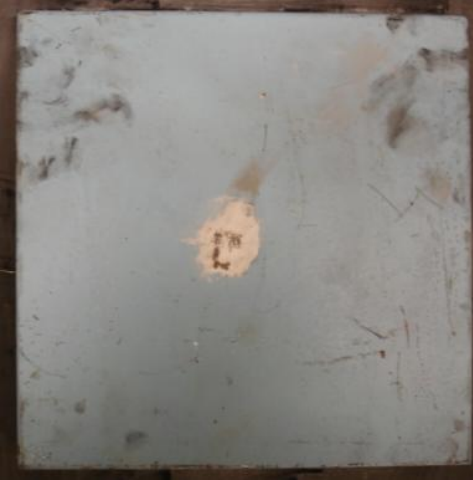
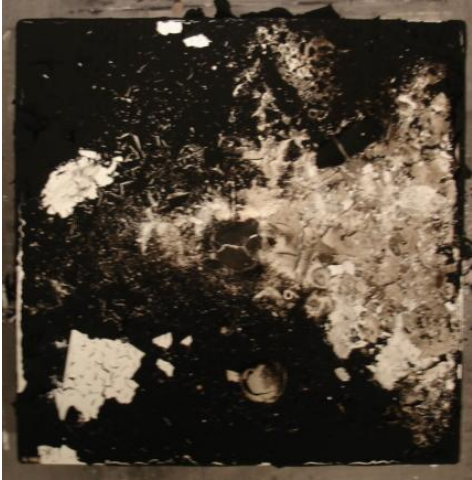
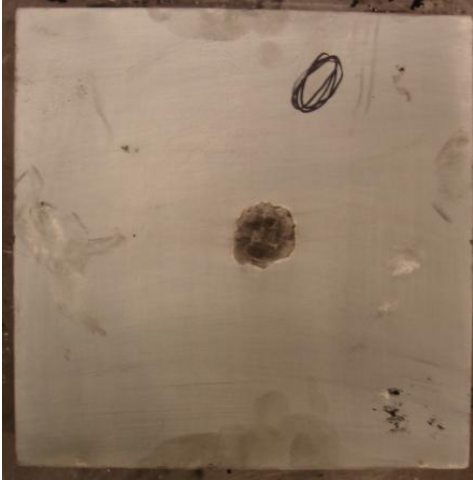
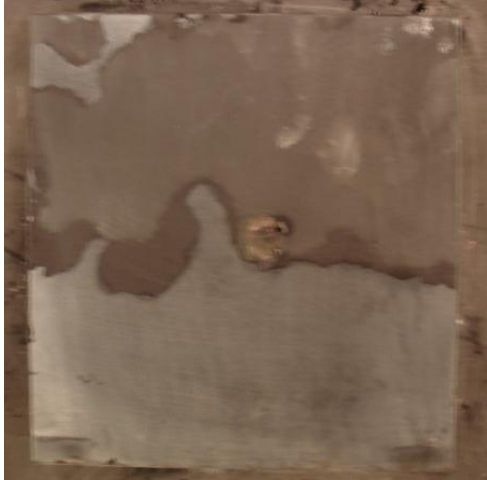
Before fire exposure	After fire exposure	After brushing surface	After washing surface

Description: Paint is in good condition. No significant scratches, chips, rust or other typical defects are apparent. (Note: The shiny white patch at plate center was where the paint was scratched off to attach thermocouples)	<i>Non-Flame Side</i> The plate surface directly exposed to flames will have little soot because the top coat of the paint will have fallen off (along with the soot) when the temperature exceeded 700 °F. The paint coating on the non-flame side will have cracked and turned white in color as shown above.	After hand wire brushing clean, most of the top coat will be eliminated from both sides. The base coat will still be intact. There will be no other significant markings (bubbles etc.) visible on the steel surfaces	After washing clean, all the soot and most of the top coat of the paint system will be removed from both the flame and non-flame sides. The base coat of the paint system will remain still intact over the plate surfaces, except for the situation of extremely long duration uncontrolled fires. For such cases, the base coat will also fall off as shown above.

Material Properties: For steel grades with nominal yield stress less than or equal to 50 ksi, fire exposure producing surface conditions as shown above will result in a small (5%) influence on the material yield strength, ultimate strength, surface hardness. The influence on the CVN fracture toughness can be _____. Conduct CVN fracture toughness tests on material samples taken from the unexposed steel to evaluate reserve margin with respect to minimum CVN toughness requirements. For heat treated steels (e.g., A514, HPS), acquire material samples from the fire-exposed and unexposed portions of the beams. Conduct CVN fracture toughness tests according to ASTM E23 to evaluate the effects of fire on steel.
