Part of  
Lawrence County Covered Bridges TR

#36-37-02      **Name:** Banks Covered Bridge  
**Location:** T476 Wilmington Township  
**UTM: Zone** 17    **N** 4548840      **E** 559960    **Acrcage:**  
**Owner:** Lawrence County

CURSORY BRIDGE INSPECTION

Bridge # 21 Banks covered bridge over the Neshannock Creek

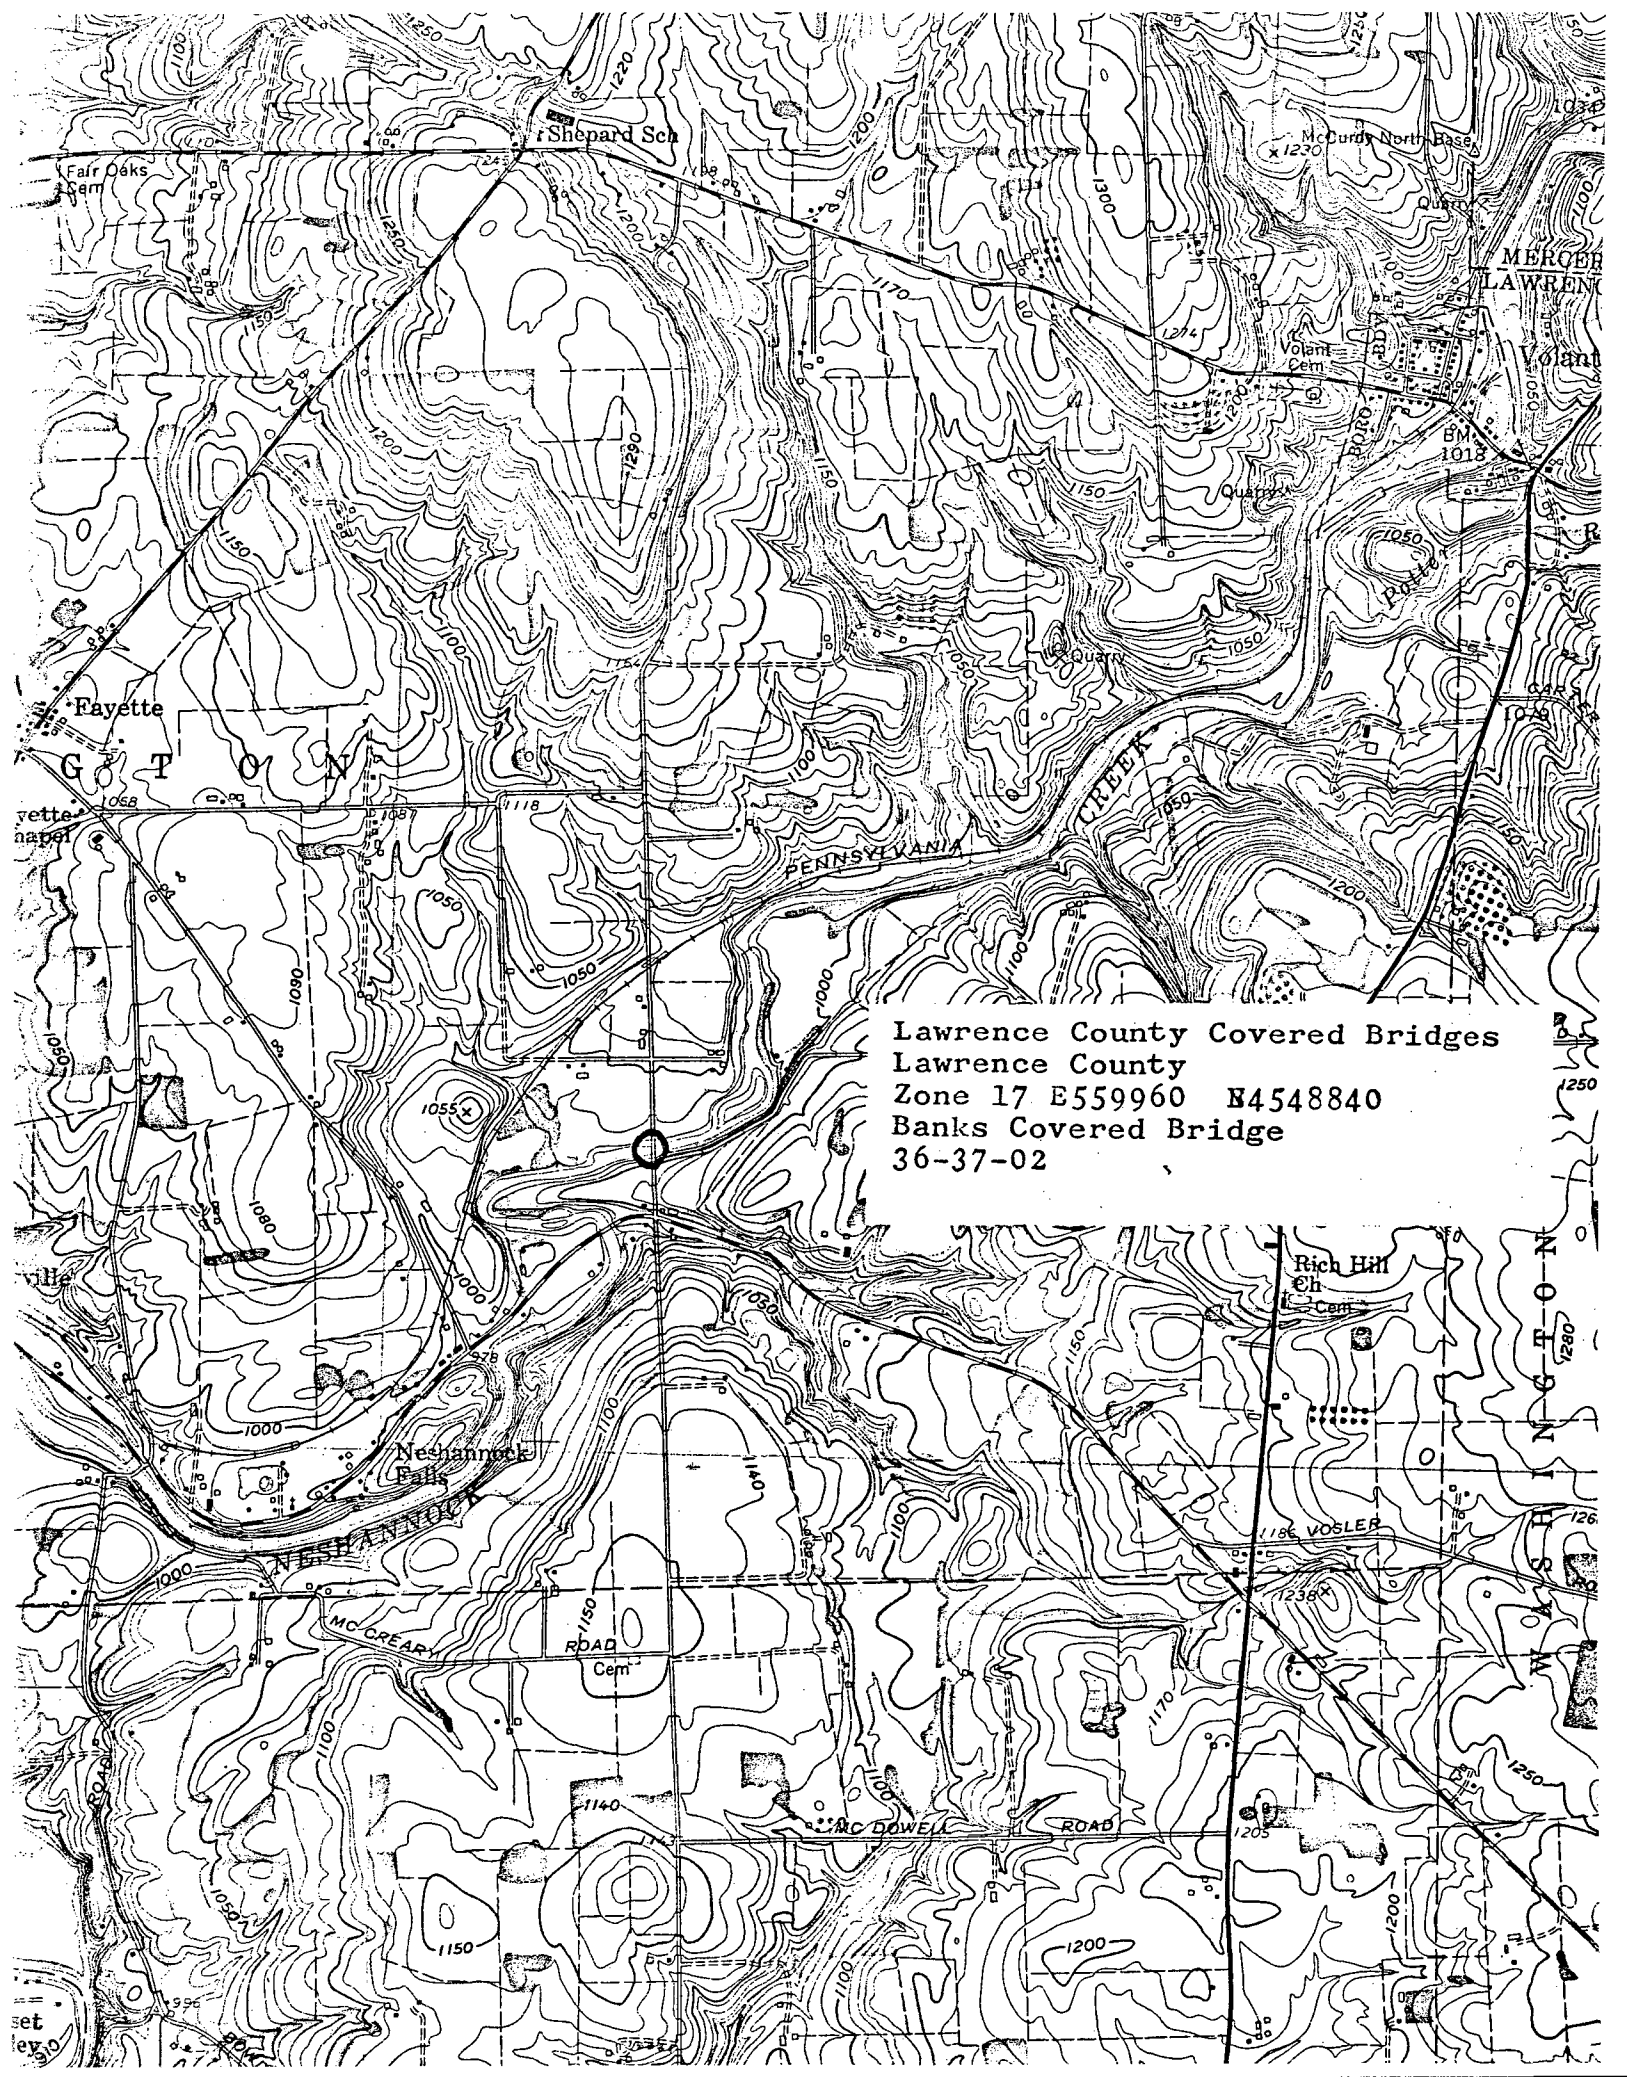
Lawrence County Covered Bridges  
Lawrence County  
Zone 17 E559960 N4548840  
Banks Covered Bridge  
36-37-02

**Distinguishing Features:** The Banks Bridge was built in 1889 and uses the Burr arch trussing system. It has a gable roof, cut stone abutments and vertical plank siding. Its portals are similar to those common in Bucks County with the interior vertical plank siding. Its walls only come to the top of the truss leaving a window area under the eaves.

**Condition:** Good
