Effects of Fire Damage on the Structural Properties of Steel Bridge Elements

FINAL REPORT

April 30, 2011

University of Pittsburgh

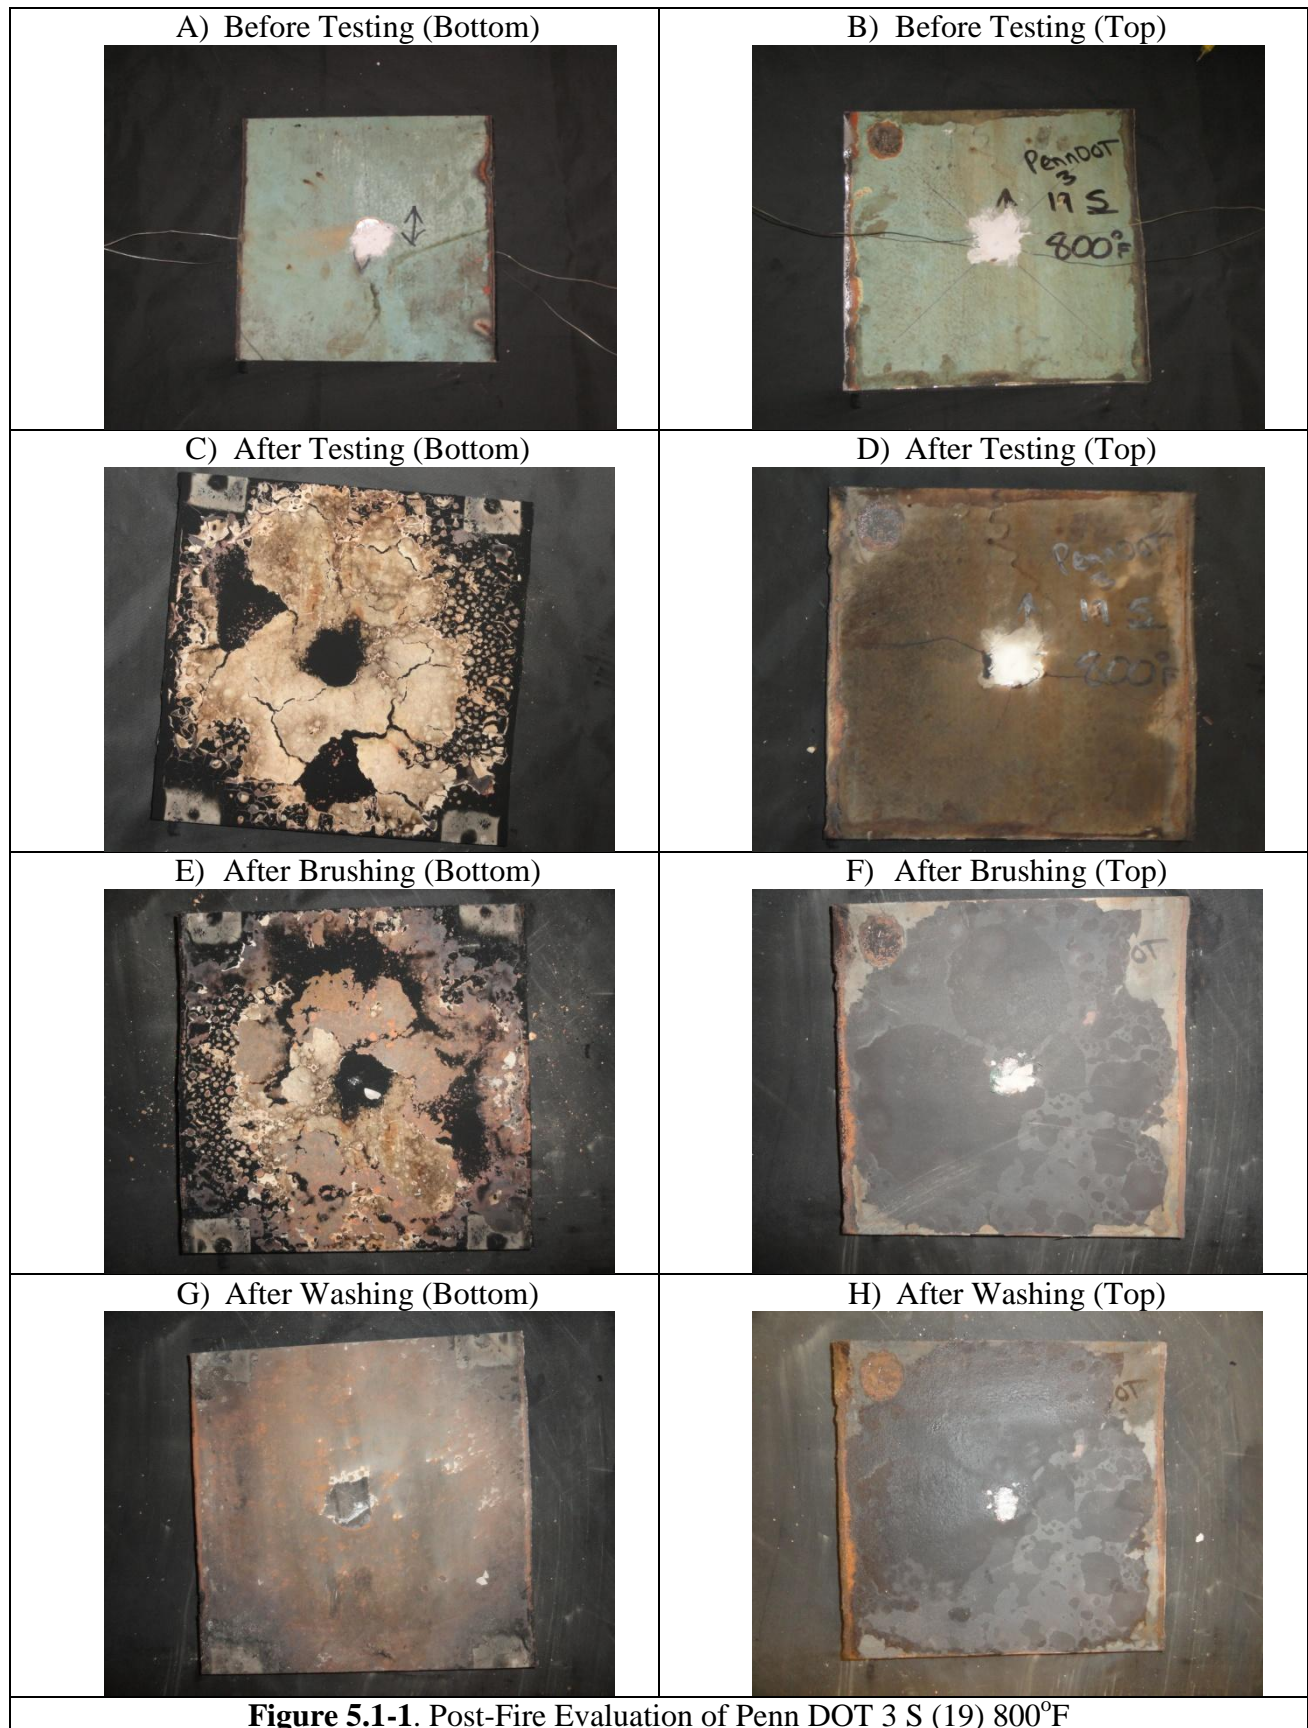
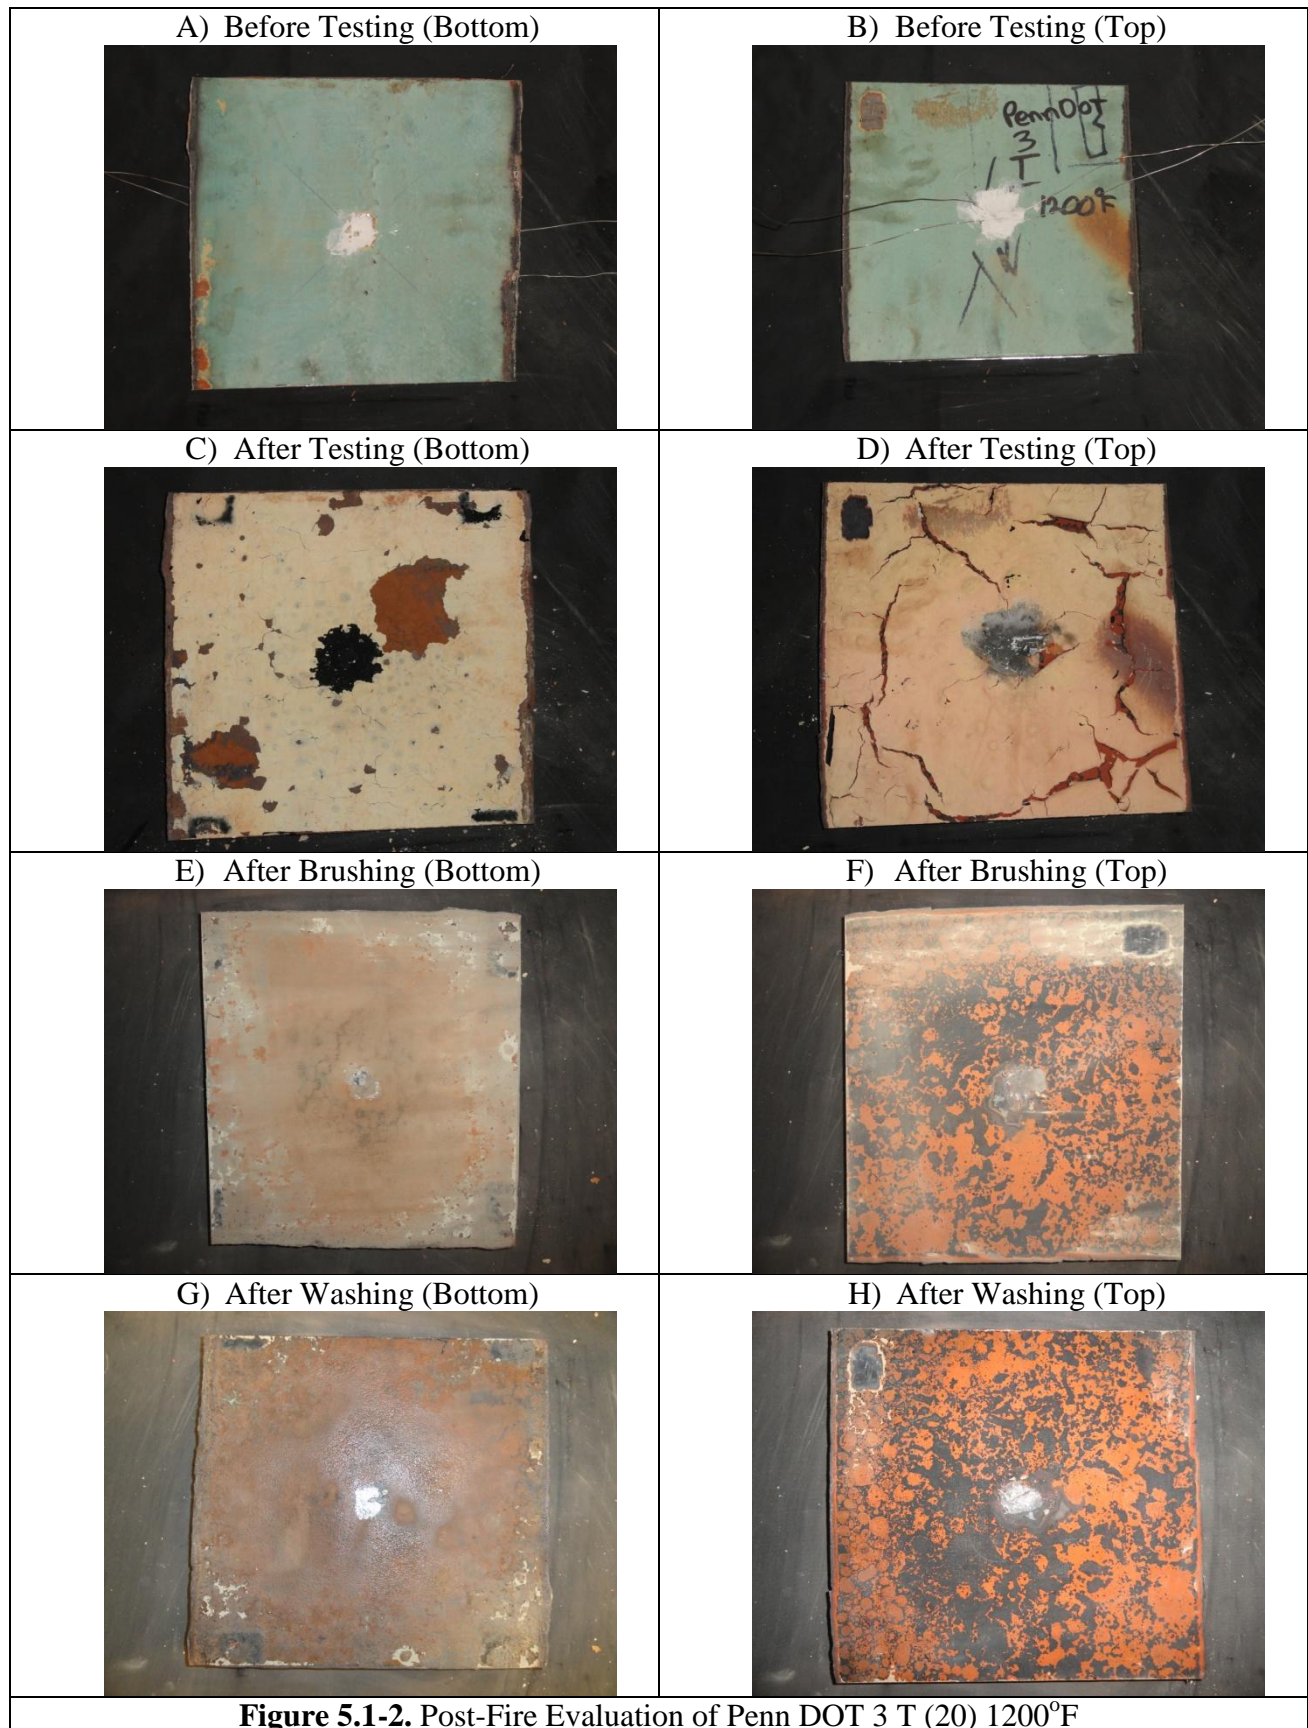
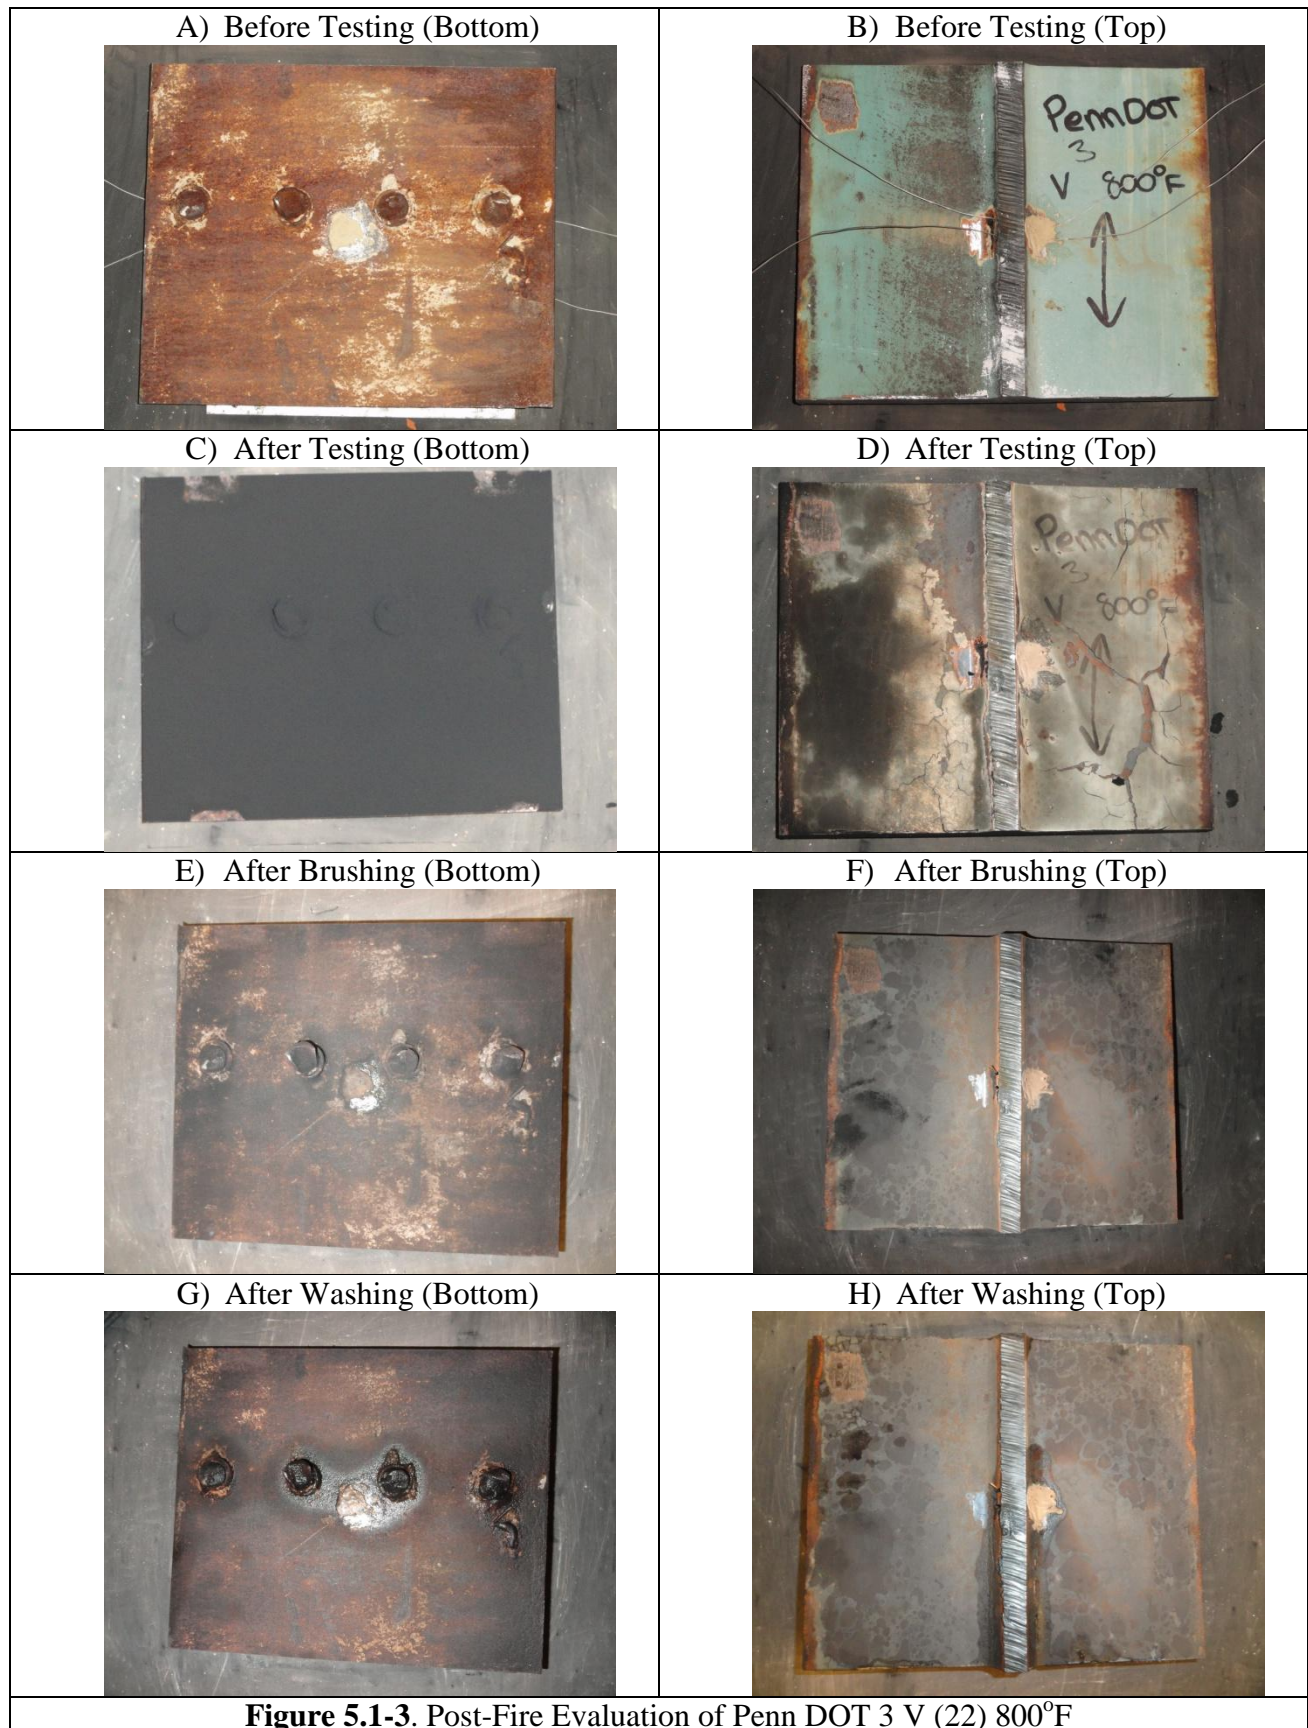
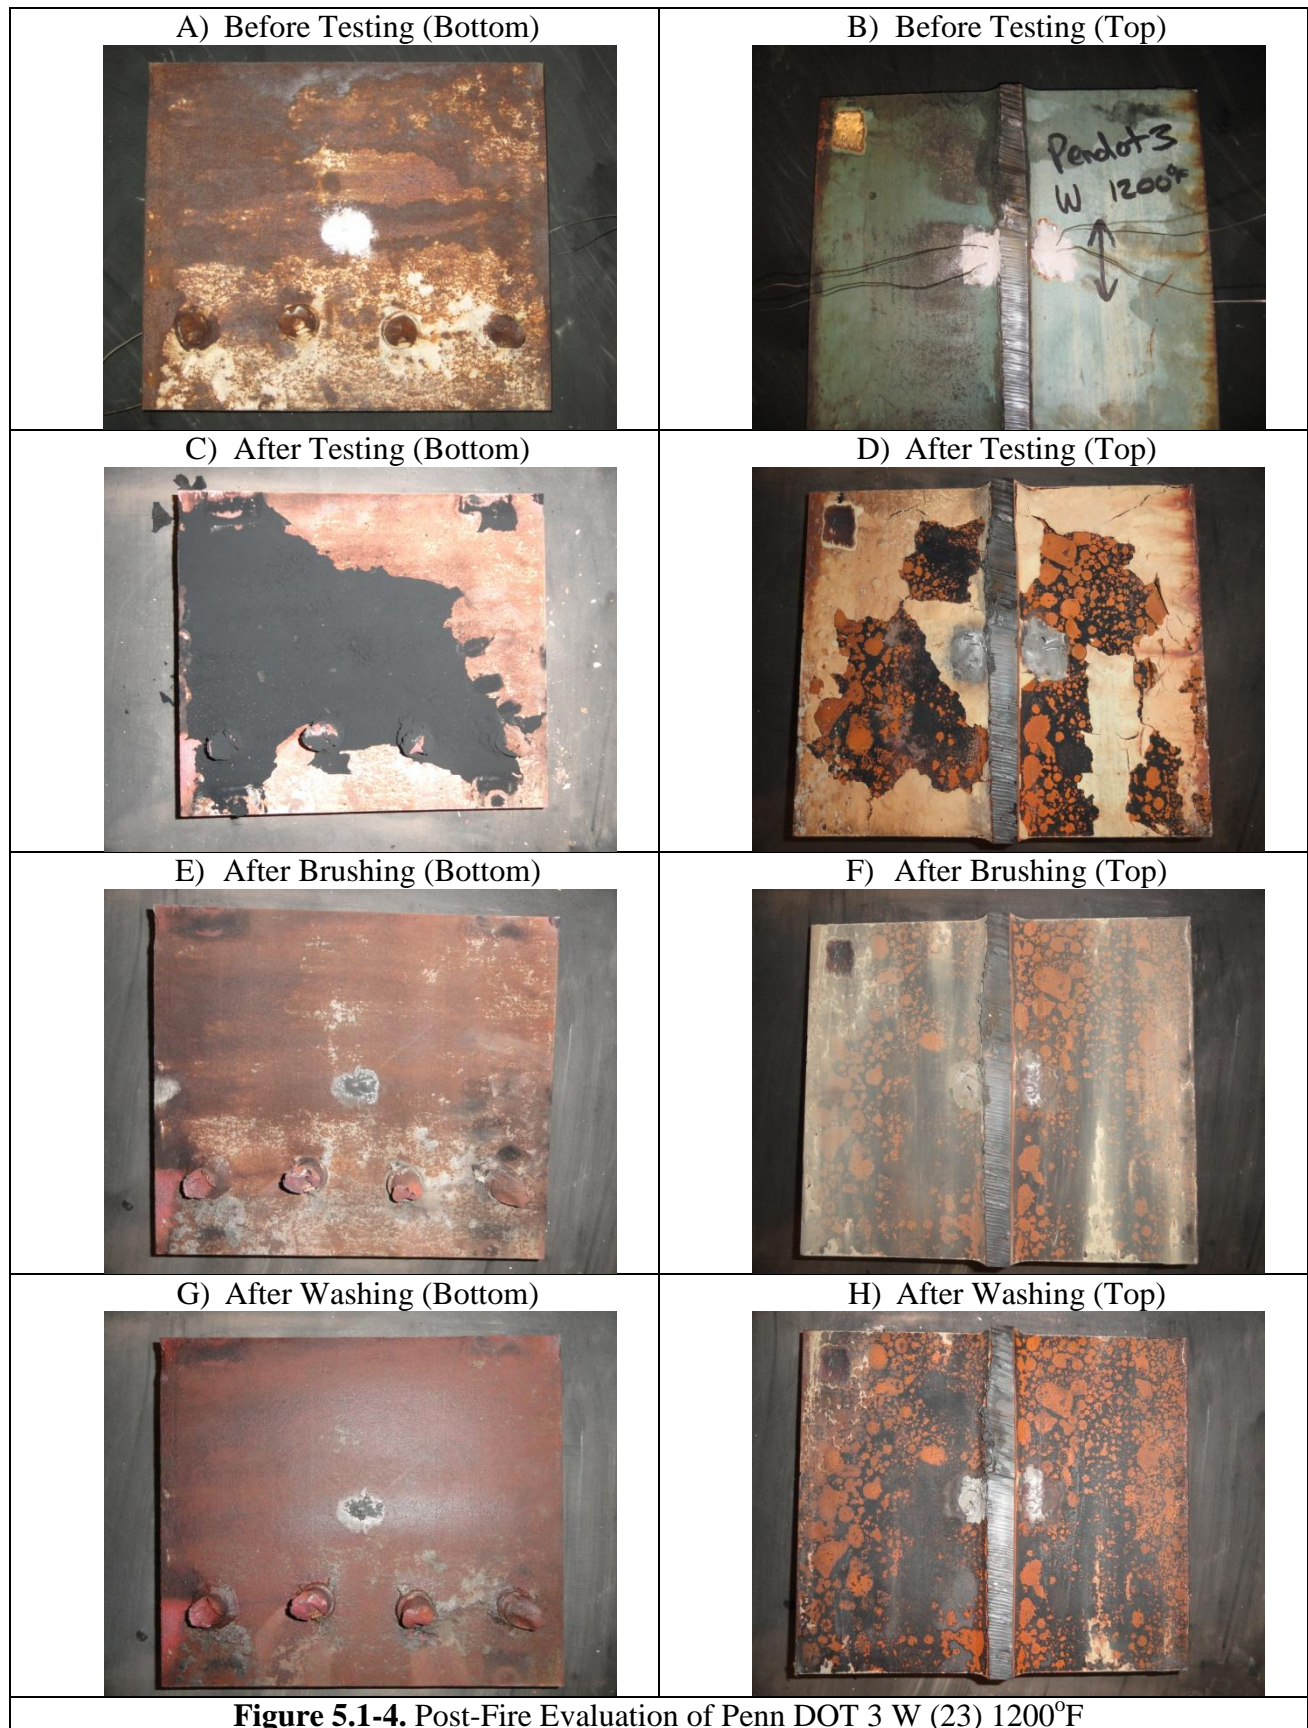
Figures 5.1-1 to 5.1-4 show photographs of the post-fire evaluation of the plate specimens (Part 1) identified in Table 4.2-1 and listed below. These include photographs taken as described in Section 4.4.

As shown in Table 5.1-1, fire exposures have only a minor effect on the steel yield strength, ultimate strength and elongation, and surface hardness. This is irrespective of the steel surface temperature achieved during the fire exposure tests and the steel plate thickness. Additionally, as shown in Table 5.1-1, the fire exposures result in only a slight reduction in the CVN fracture toughness values for the steels. The reduction is slightly higher for the thicker (¾ in. thick) steel plates.

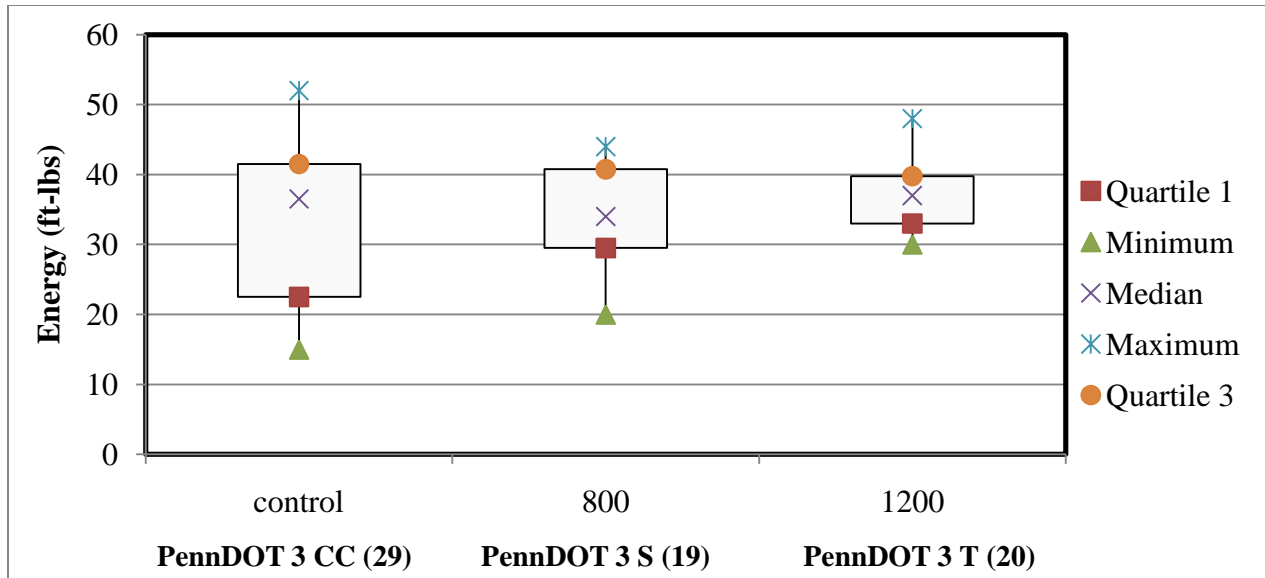
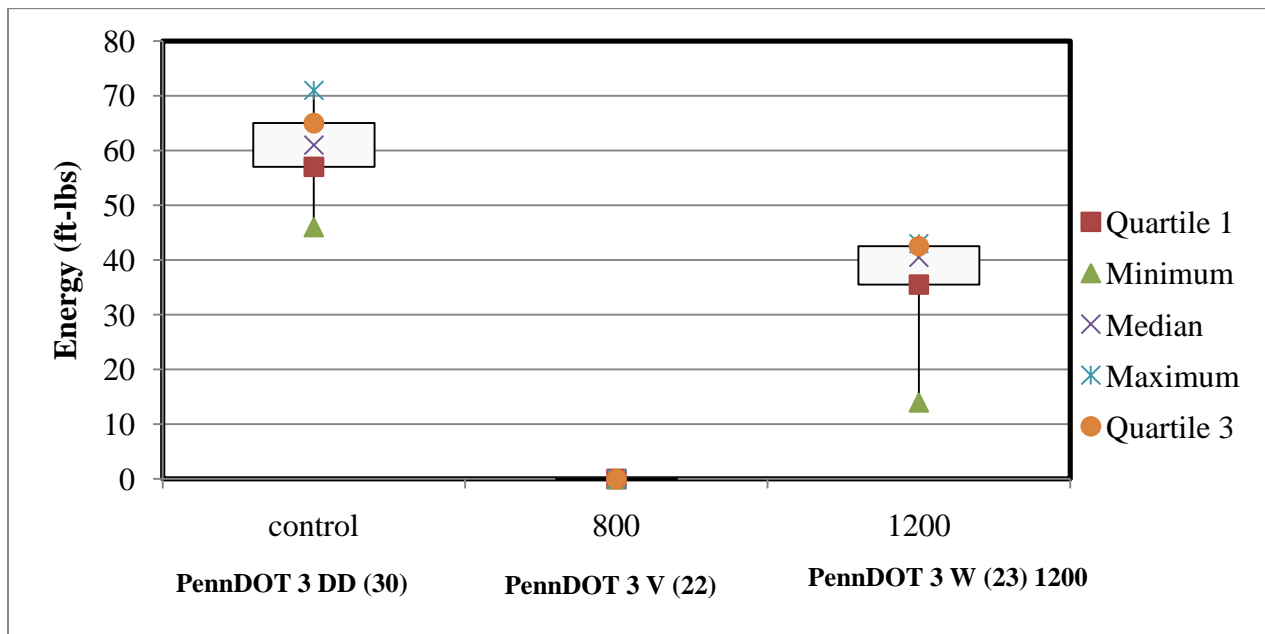
Figures 5.1-7 and 5.1-8 shows box plots that can be used to more comprehensively evaluate the effects of fire exposure on the CVN fracture toughness of steels. These figures focus on ½ in. thick and ¾ in. thick steel plates that had been subjected to controlled fire exposure using the flame jet setup. The box plots include for each plate specimen: (i) the minimum, maximum, and median values of fracture toughness, and (ii) the first and third quartile fracture toughness values. The first quartile means that 25% of the values will be lower than this value, and third quartile means 75% of the values will be lower than this value. These Figures 5.1-7 and 5.1-8 show that the fire exposures do not have a statistically significant effect on the CVN fracture toughness of steels, which numerically still satisfies the 15 ft-lb limit for Zone 2 (AASHTO 2010 §6.6.2).

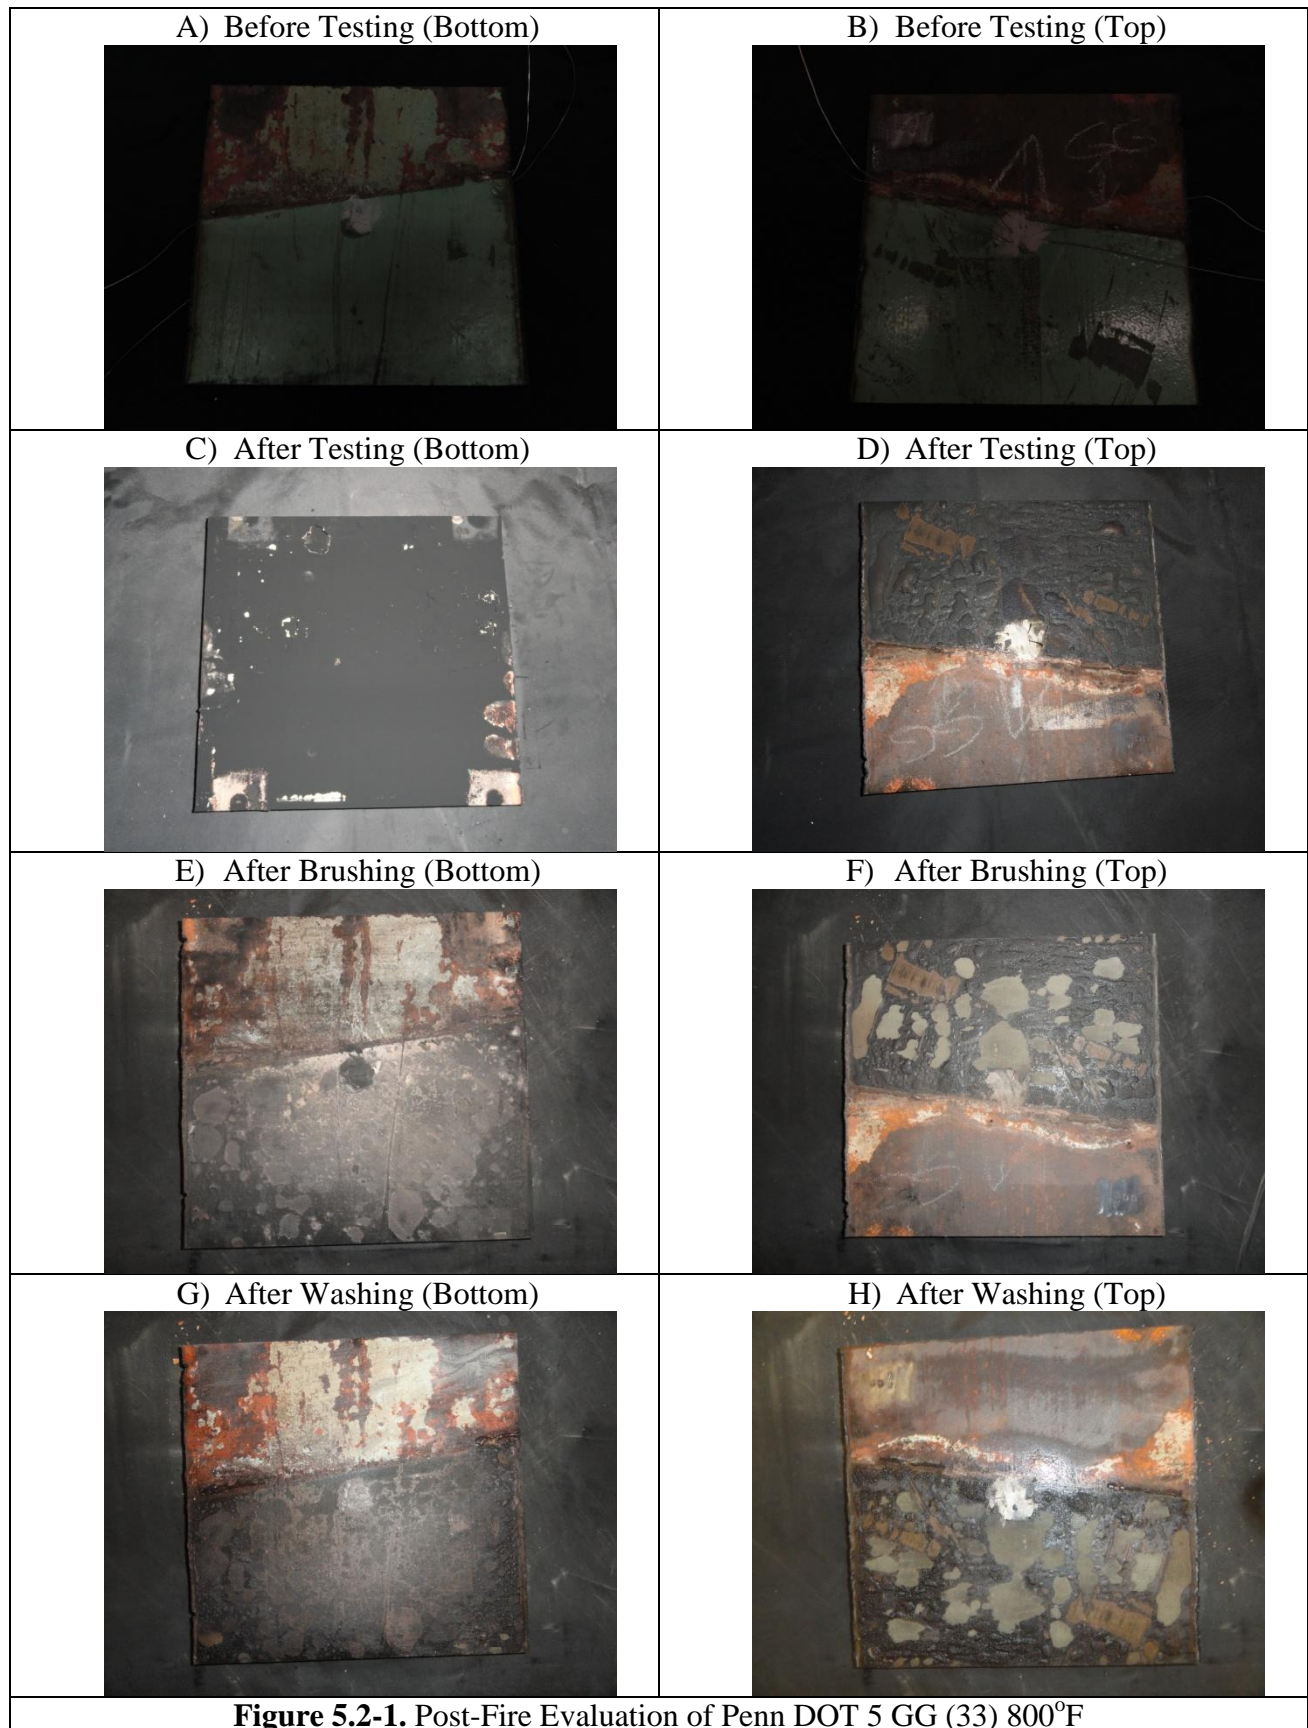
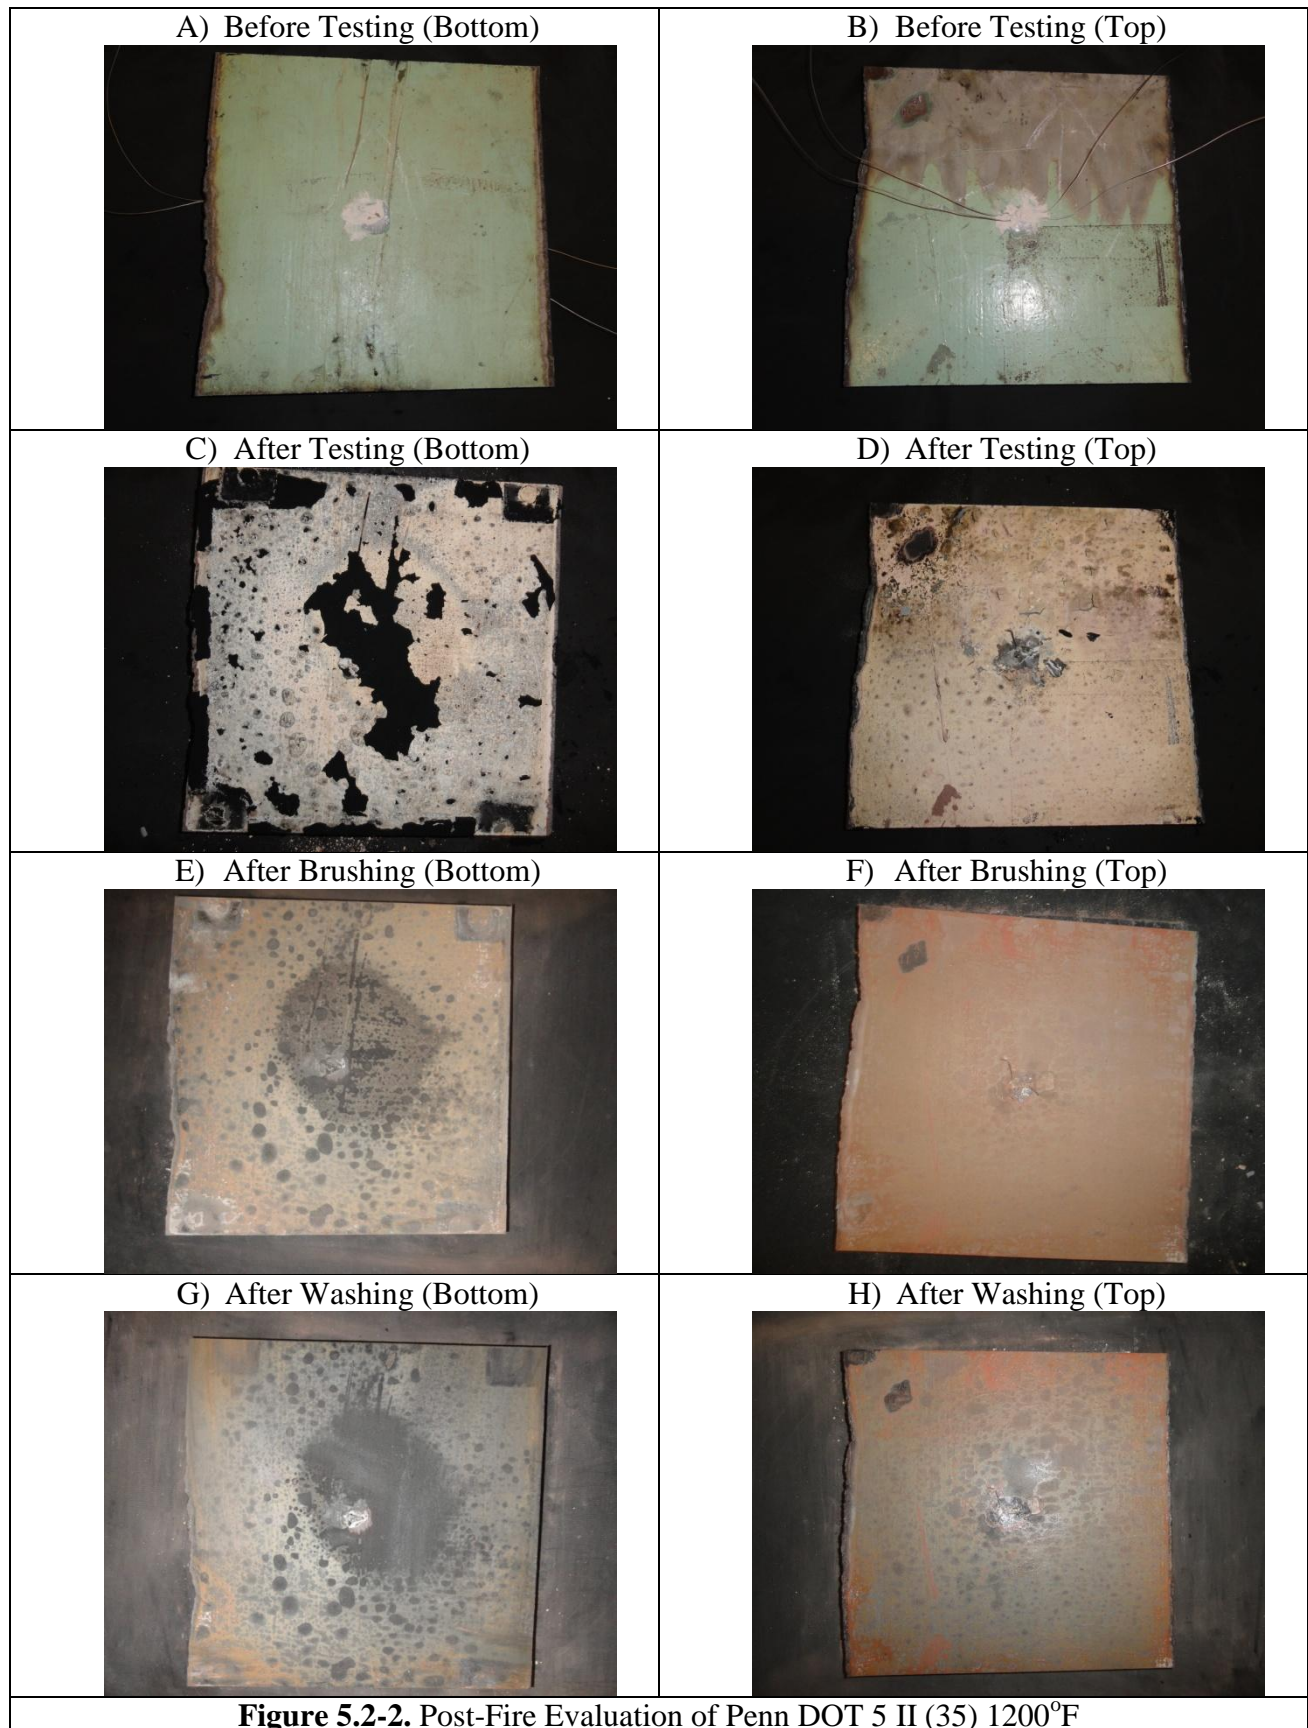
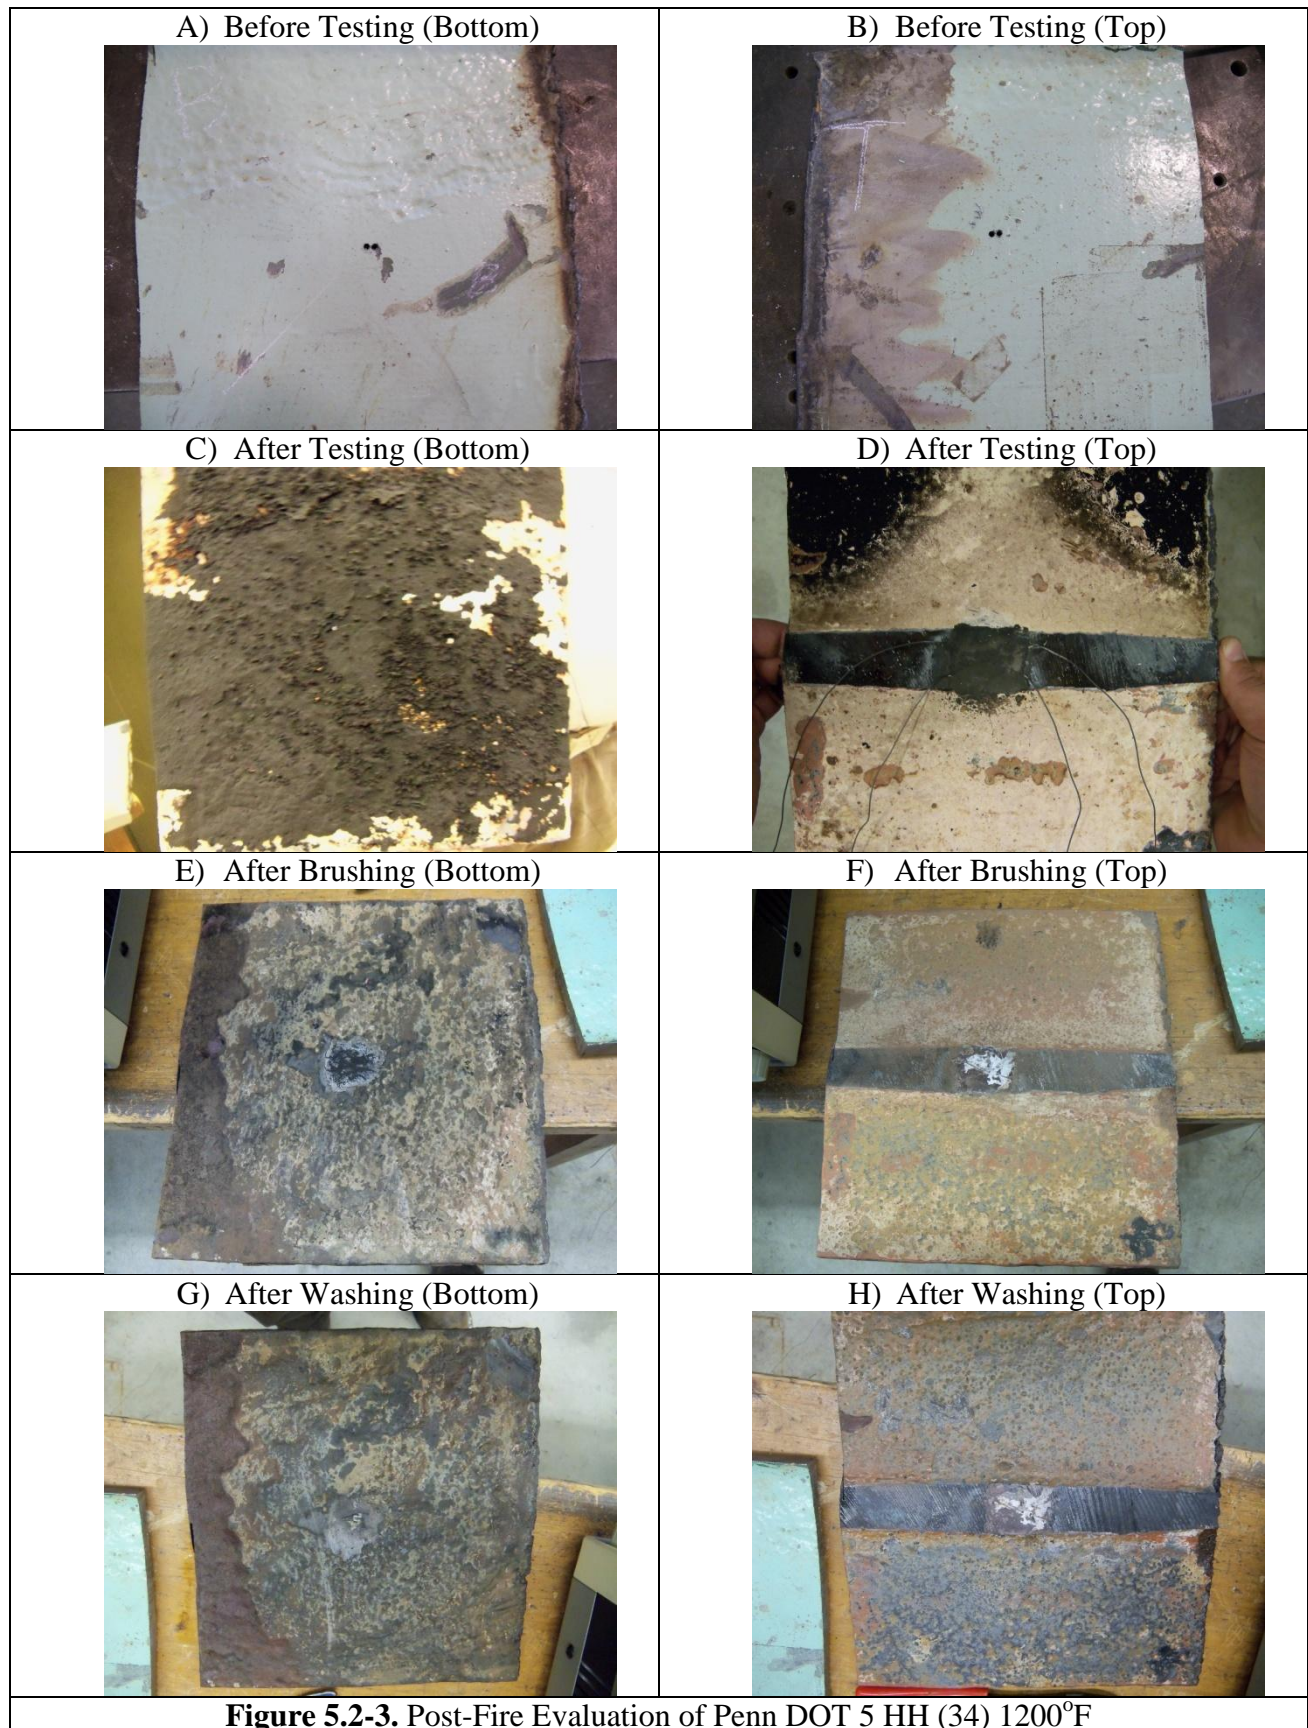
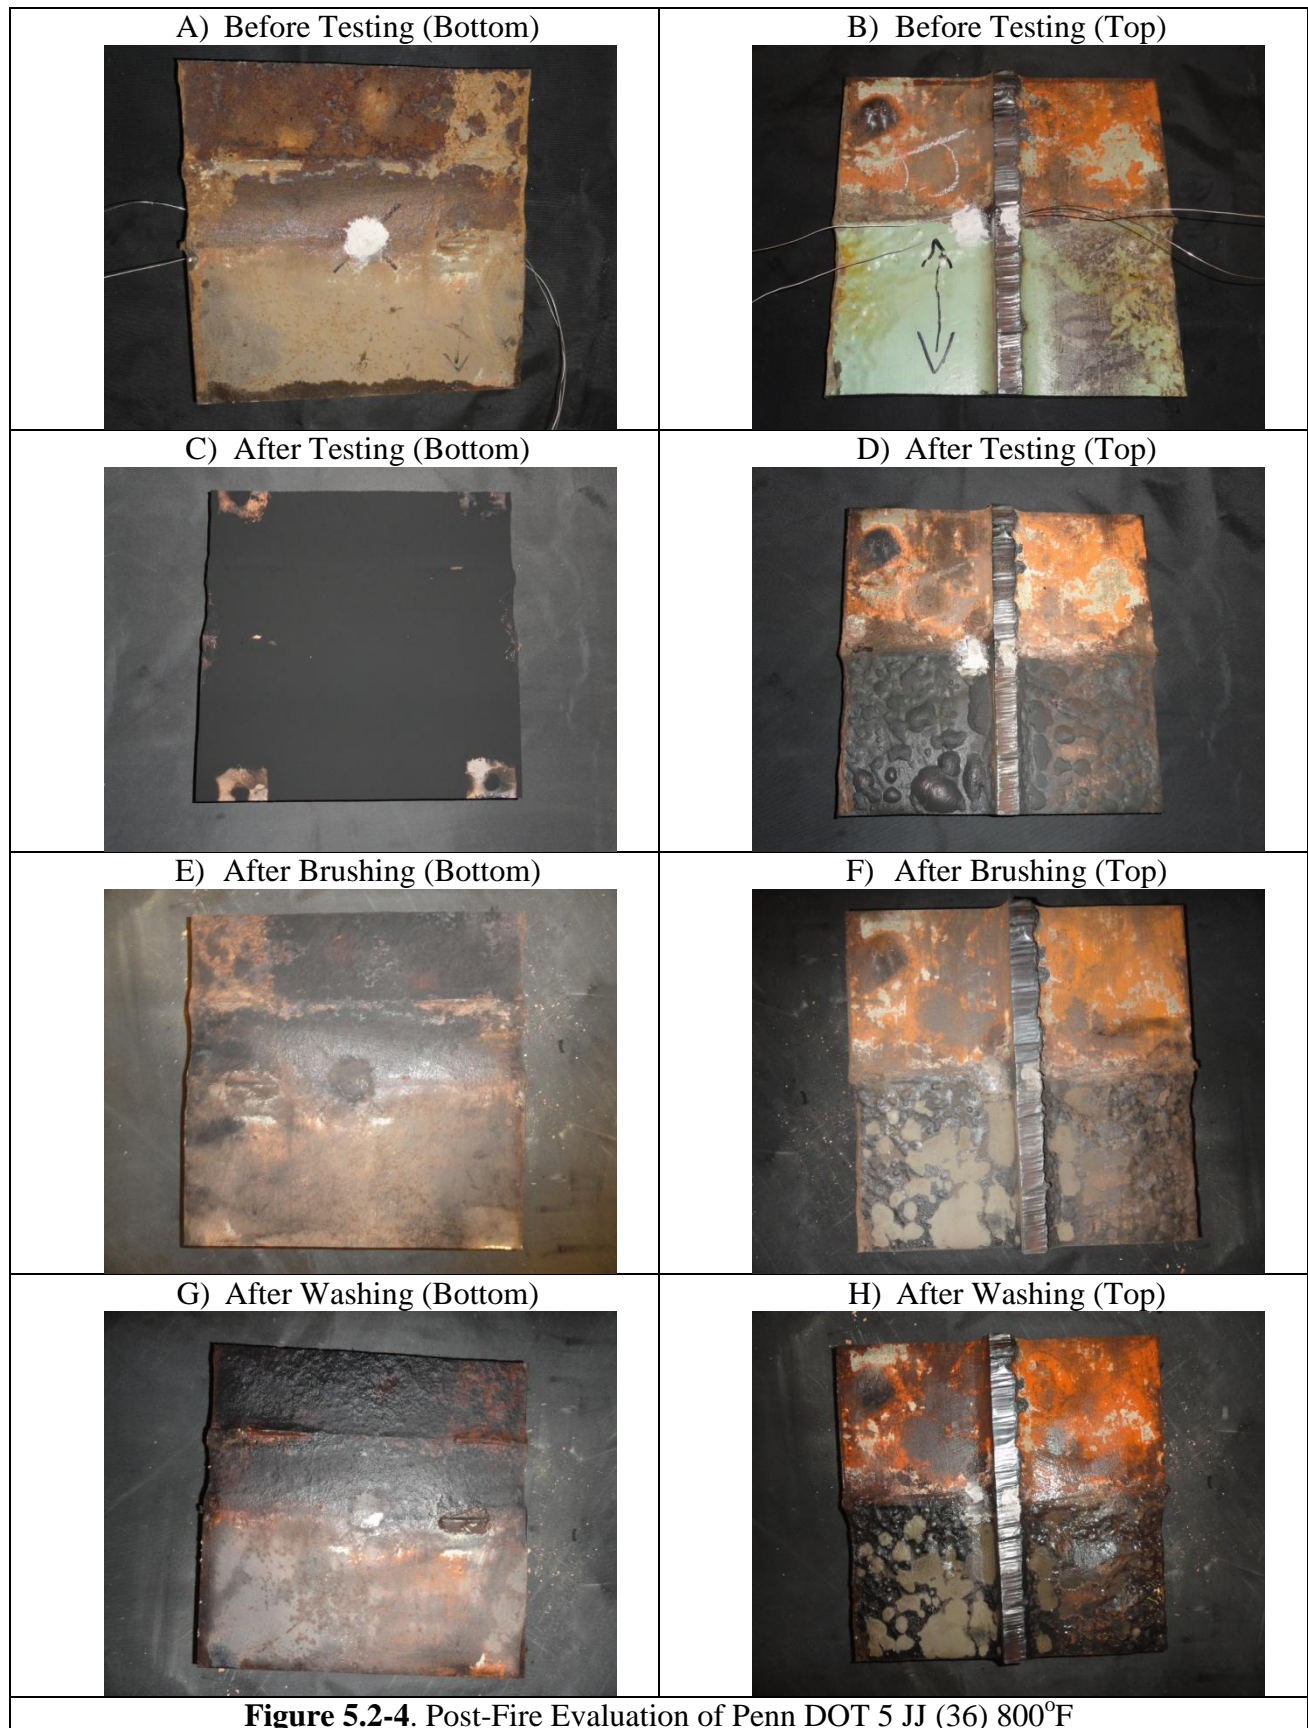
Figures 5.2-1 to 5.2-4 show photographs of the post-fire evaluation of the plate specimens (Part 2) identified in Table 4.2-1 and listed below. These include photographs taken as described in Section 4.4.

Additionally, Table 5.2-1 includes the standard material test results obtained by testing the coupons fabricated from the ½ in. thick plate specimens identified in Table 4.2-1. As shown in Table 5.2-1, fire exposures have only a minor effect on the steel yield strength, ultimate strength and elongation, and surface hardness. This is irrespective of the steel surface temperature achieved during the fire exposure tests. Additionally, as shown in Table 5.2-1, the fire exposures result in only a slight reduction in the CVN fracture toughness values for the steels.

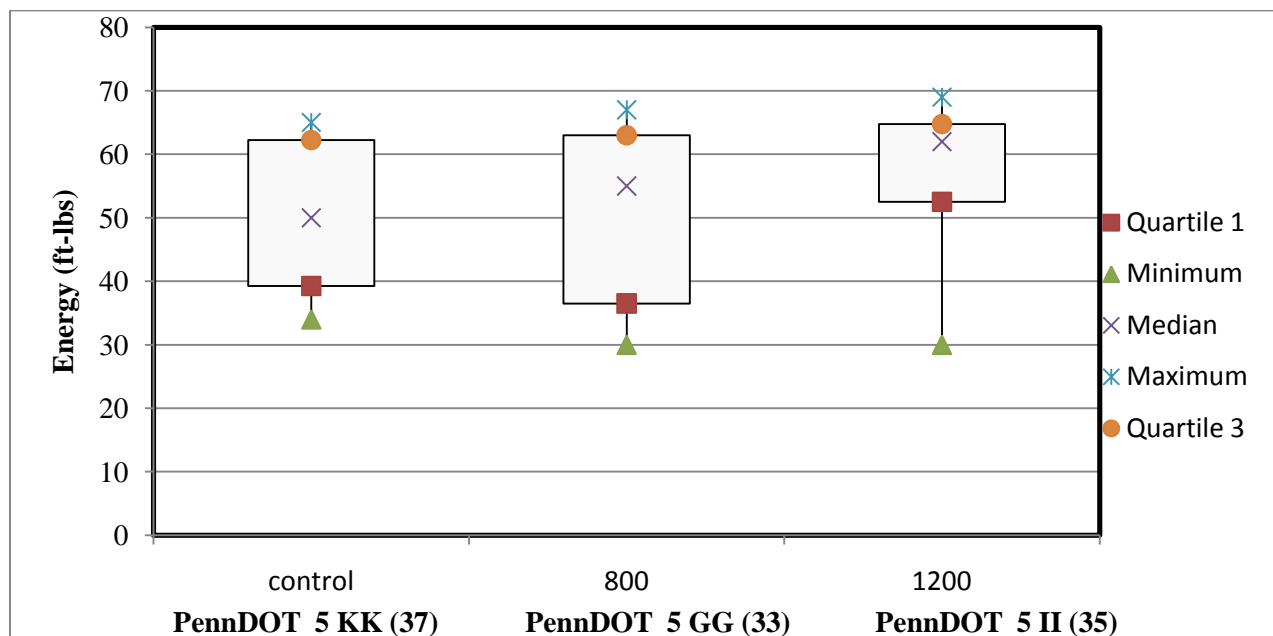
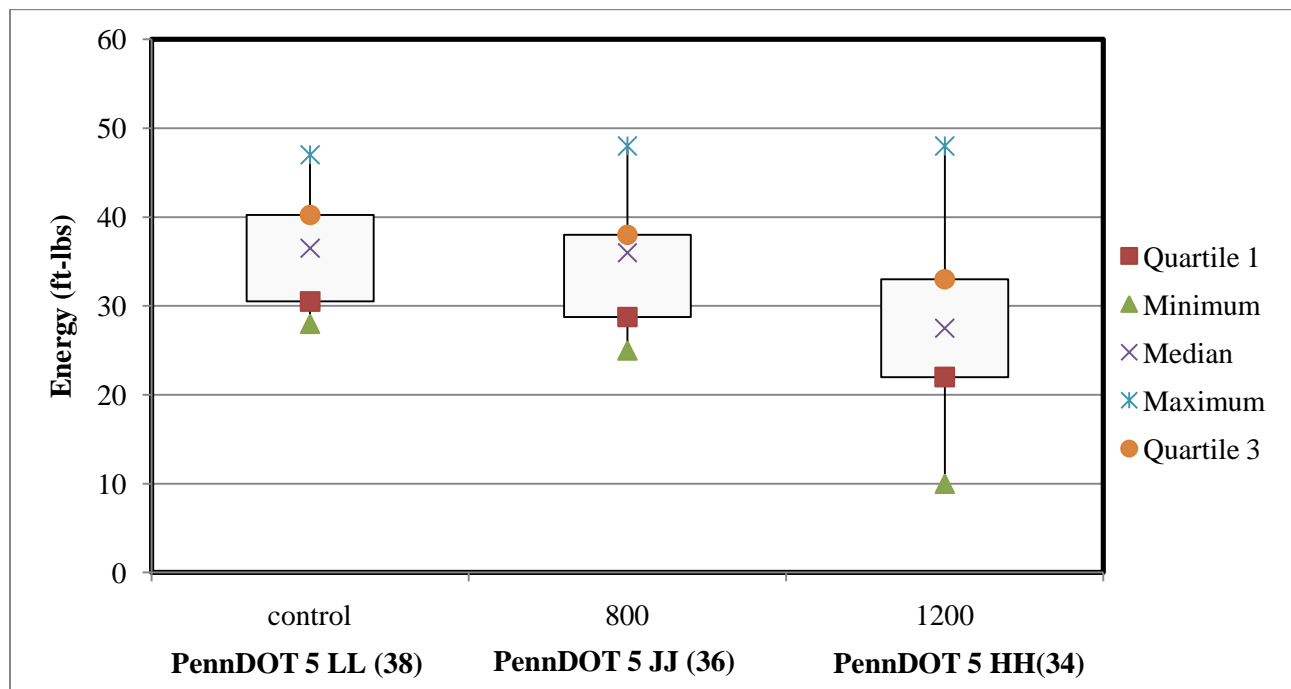
Figures 5.2-7 and 5.2-8 shows box plots that can be used to more comprehensively evaluate the effects of fire exposure on the CVN fracture toughness of steels. These figures focus on ½ in. thick webs and the 1/2 in. thick flange steel plates that had been subjected to controlled fire exposure using the flame jet setup. The box plots include for each plate specimen: (i) the minimum, maximum, and median values of fracture toughness, and (ii) the first and third quartile fracture toughness values. The first quartile means that 25% of the values will be lower than this value, and third quartile means 75% of the values will be lower than this value. These Figures show that the fire exposures do not have a statistically significant effect on the CVN fracture toughness of steels, which numerically still satisfies the 15 ft-lb limit for Zone 2 (AASHTO 2010 §6.6.2).
