Effects of Fire Damage on the Structural Properties of Steel Bridge Elements

FINAL REPORT

April 30, 2011

University of Pittsburgh

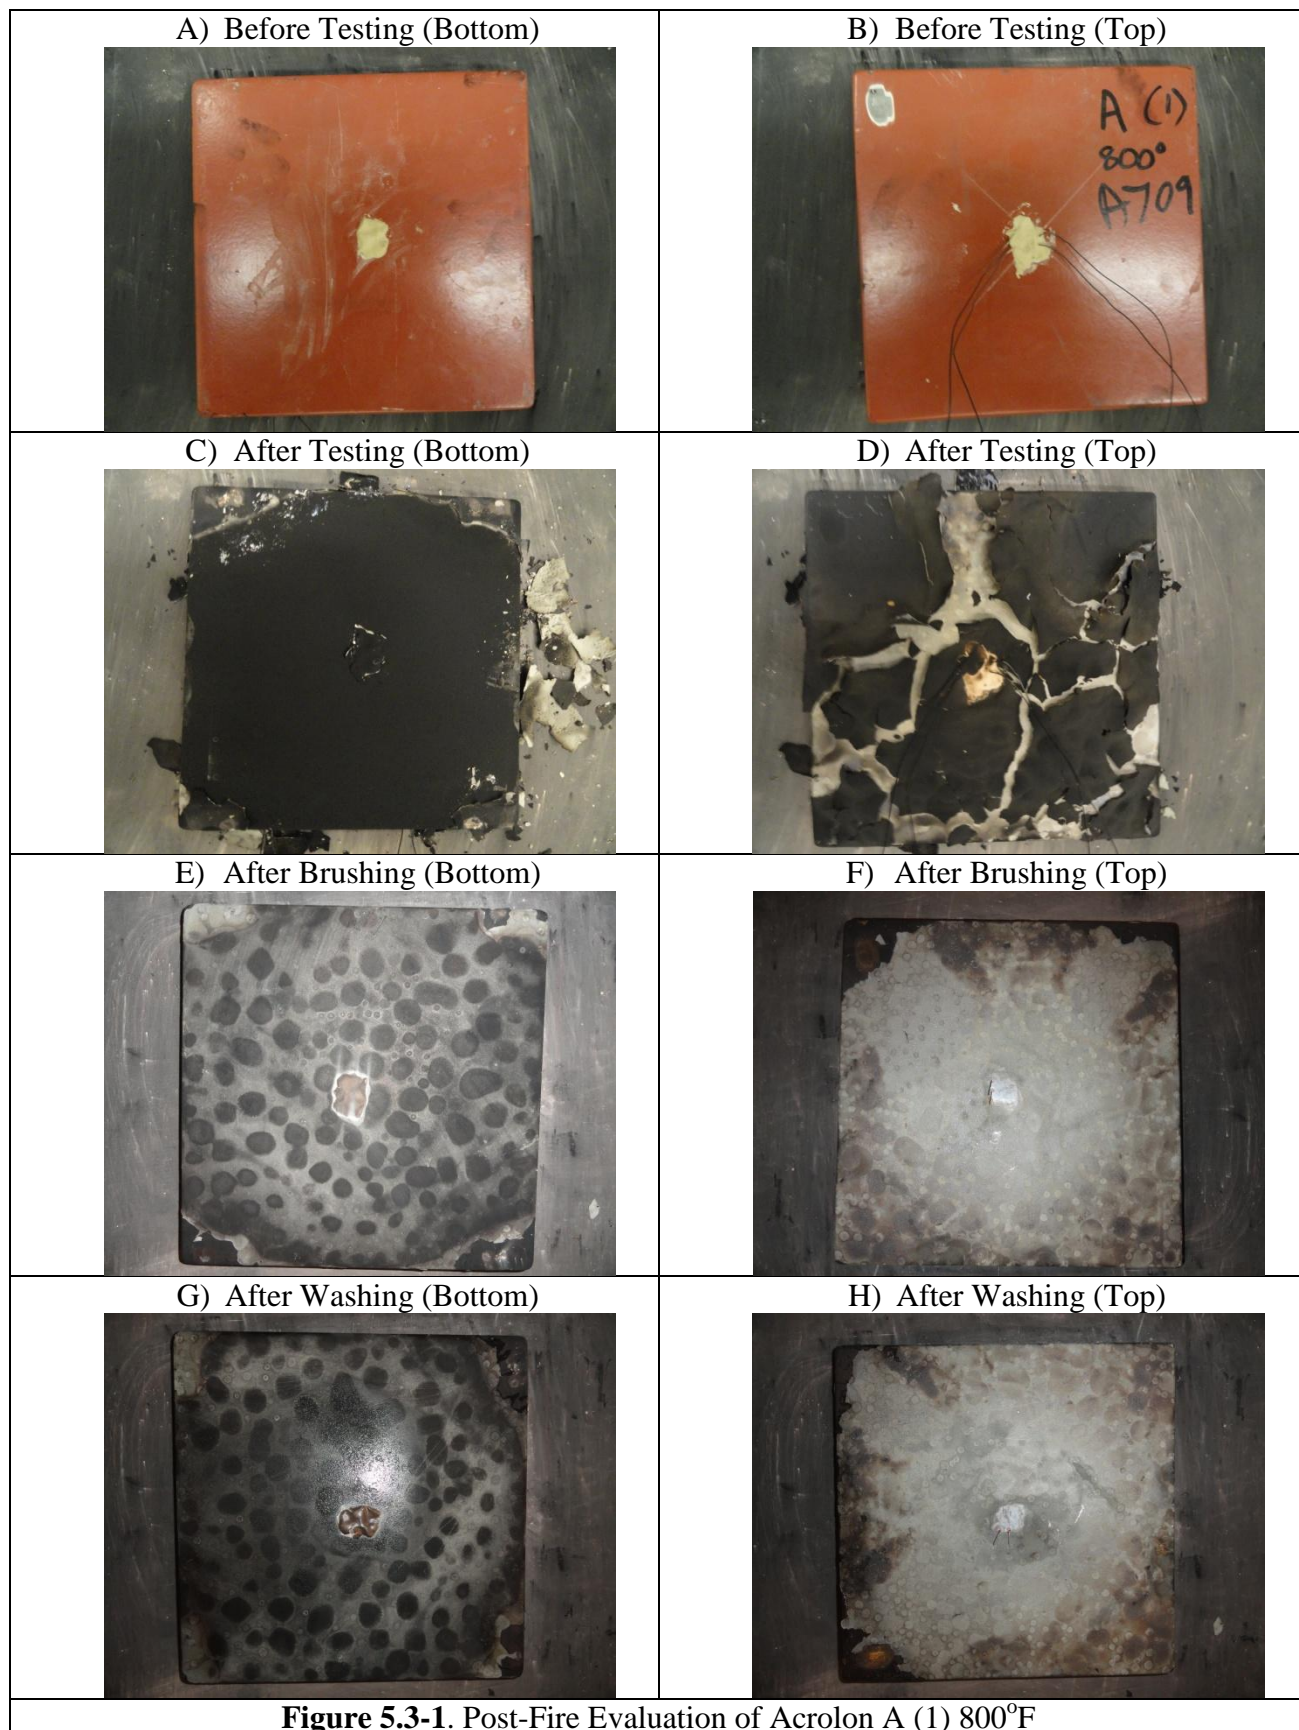
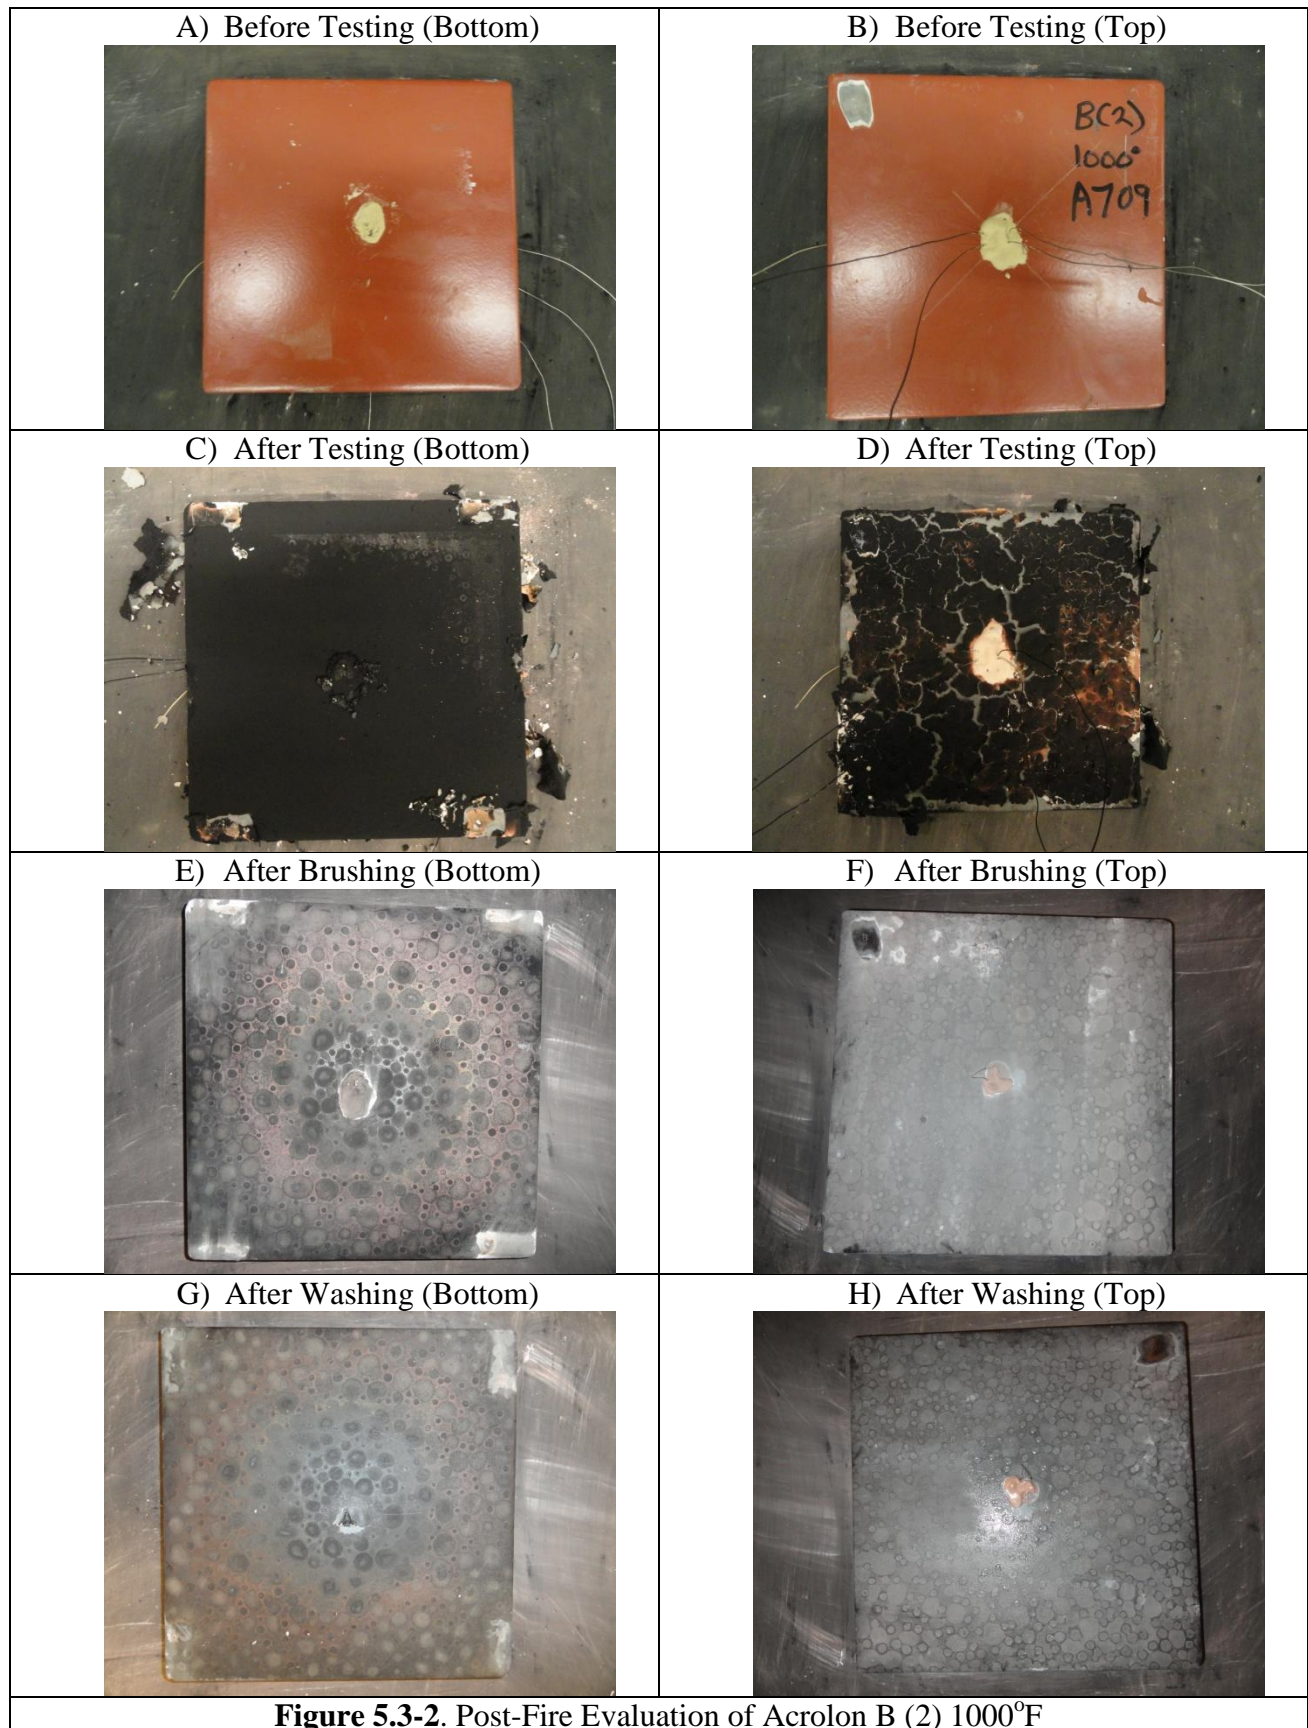
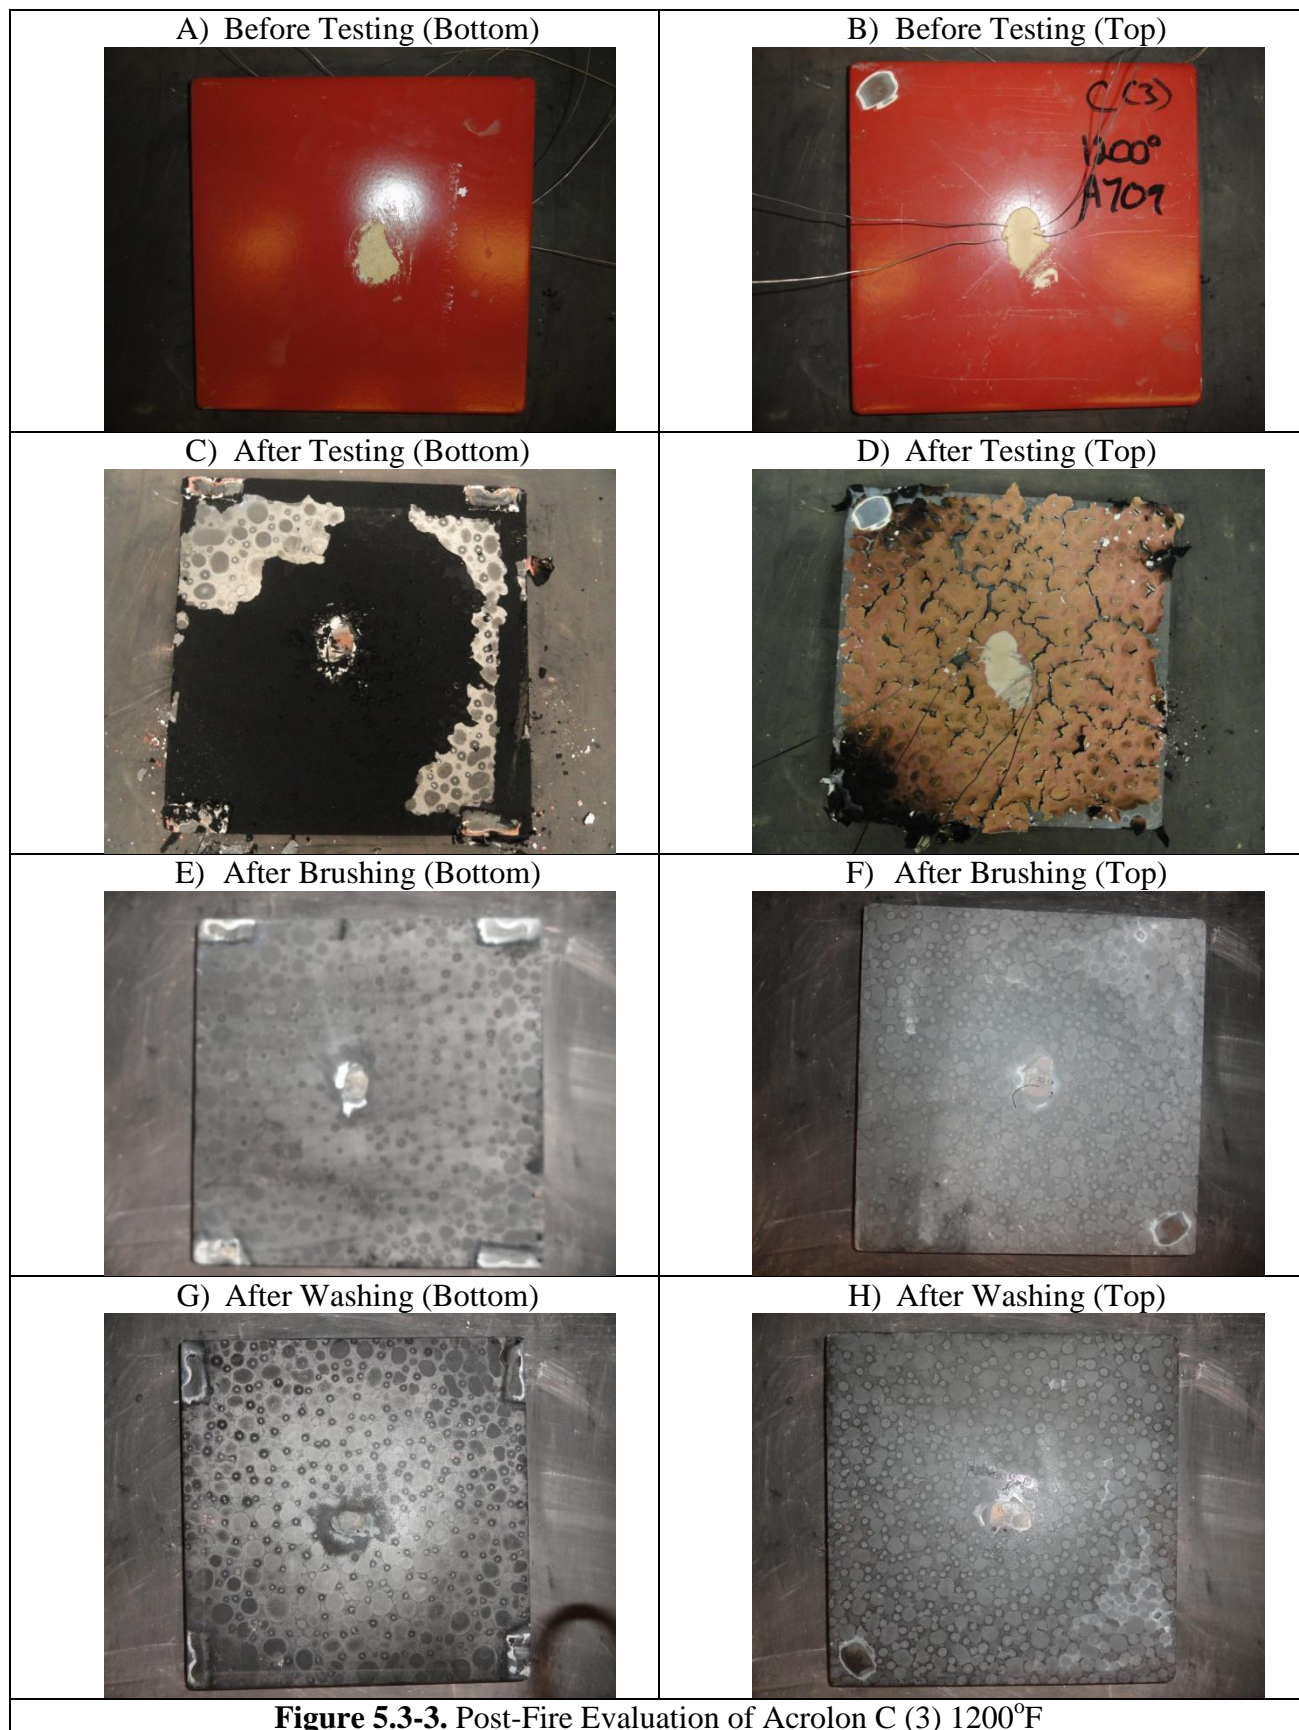
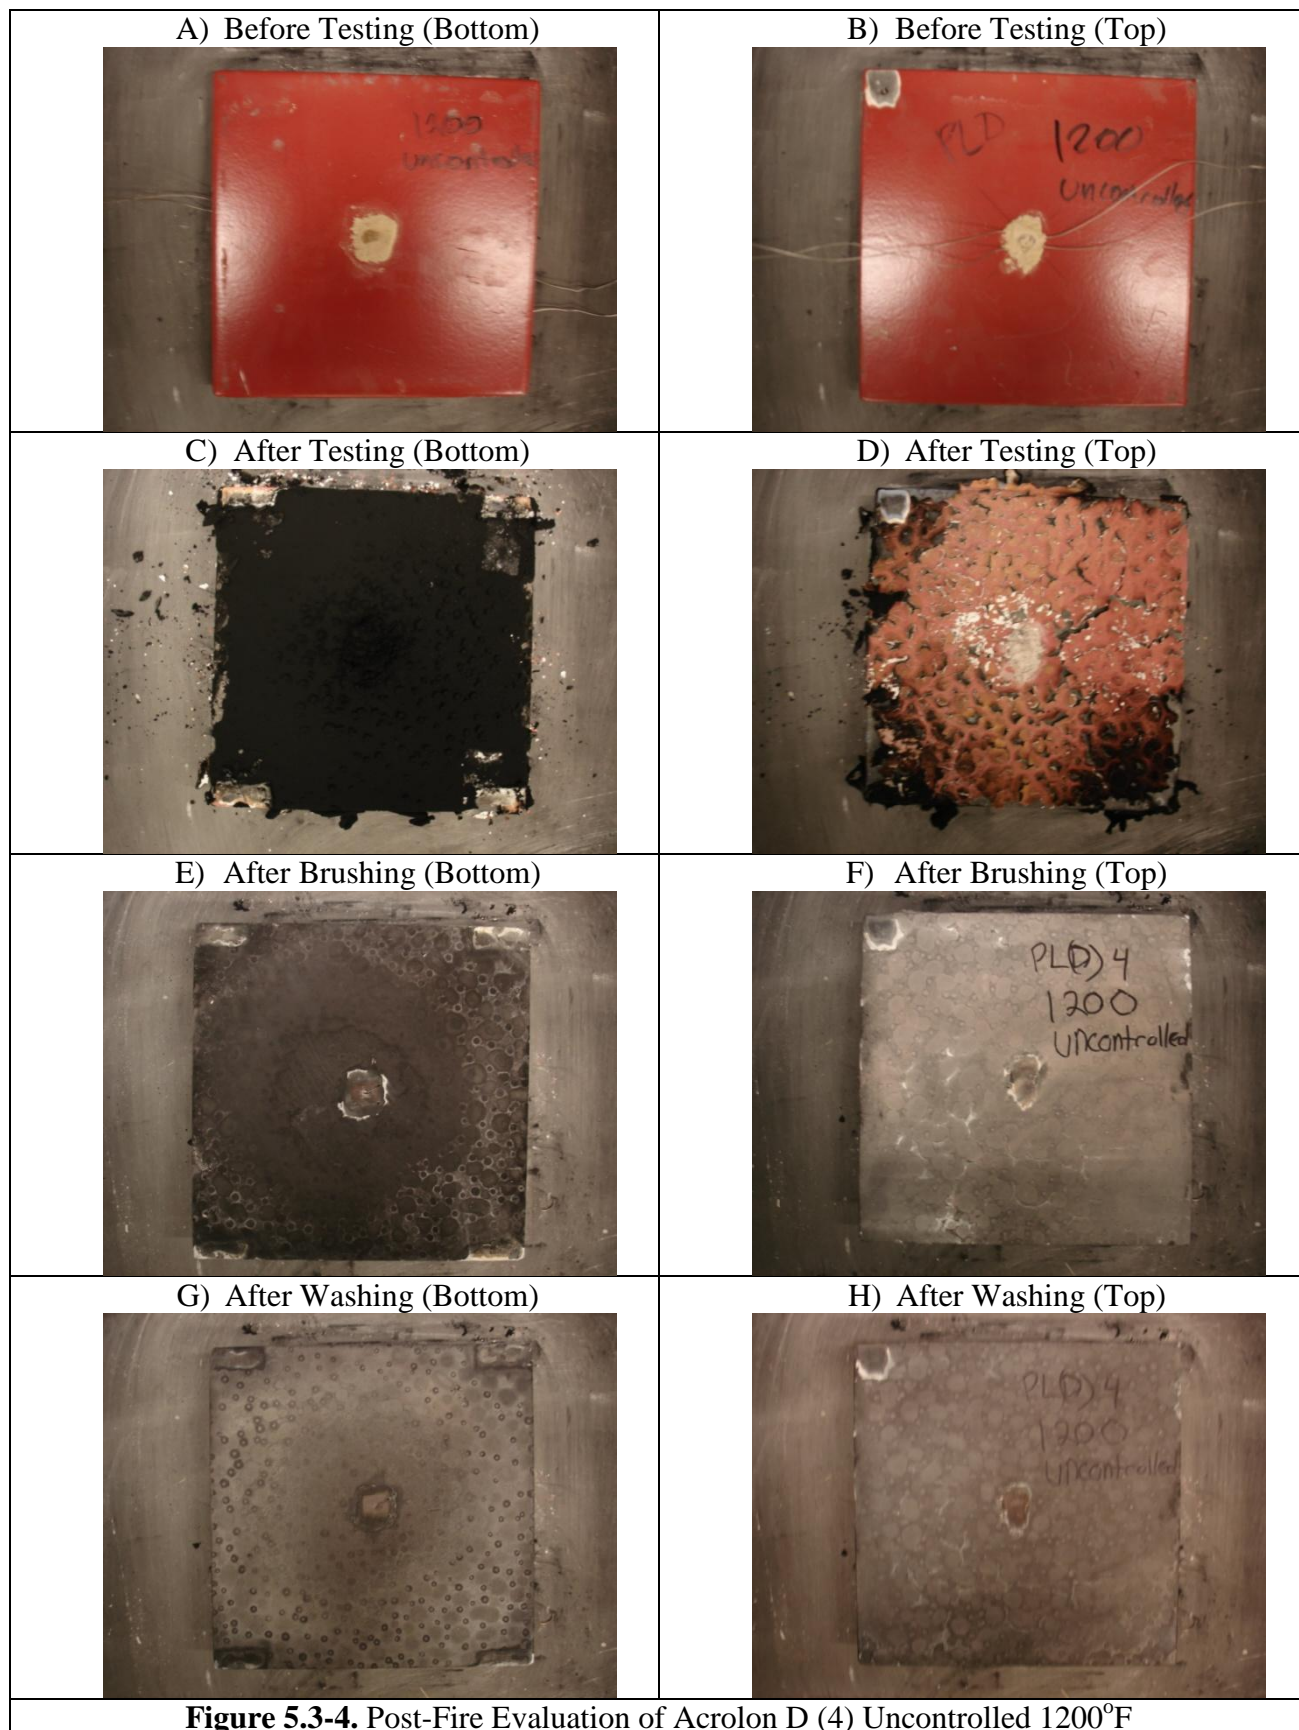
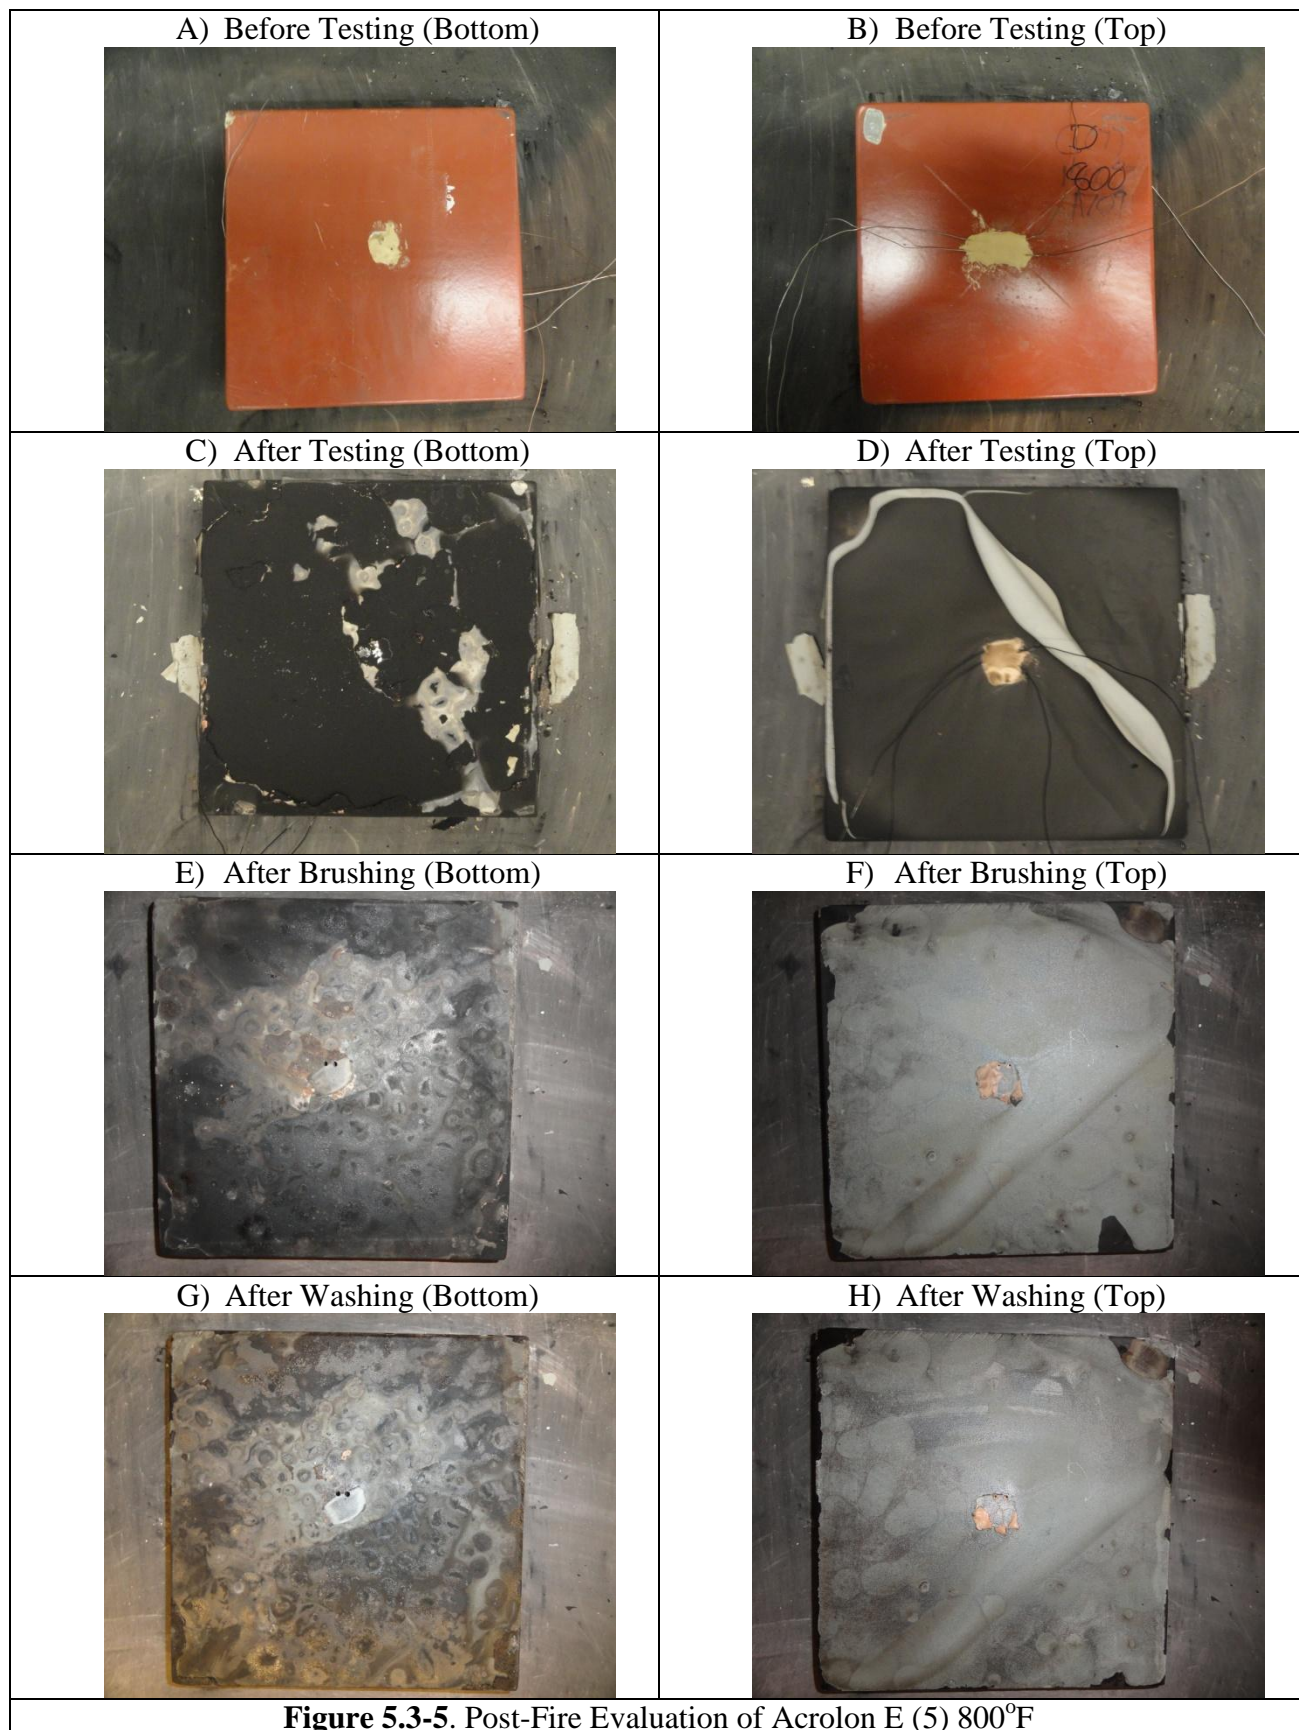
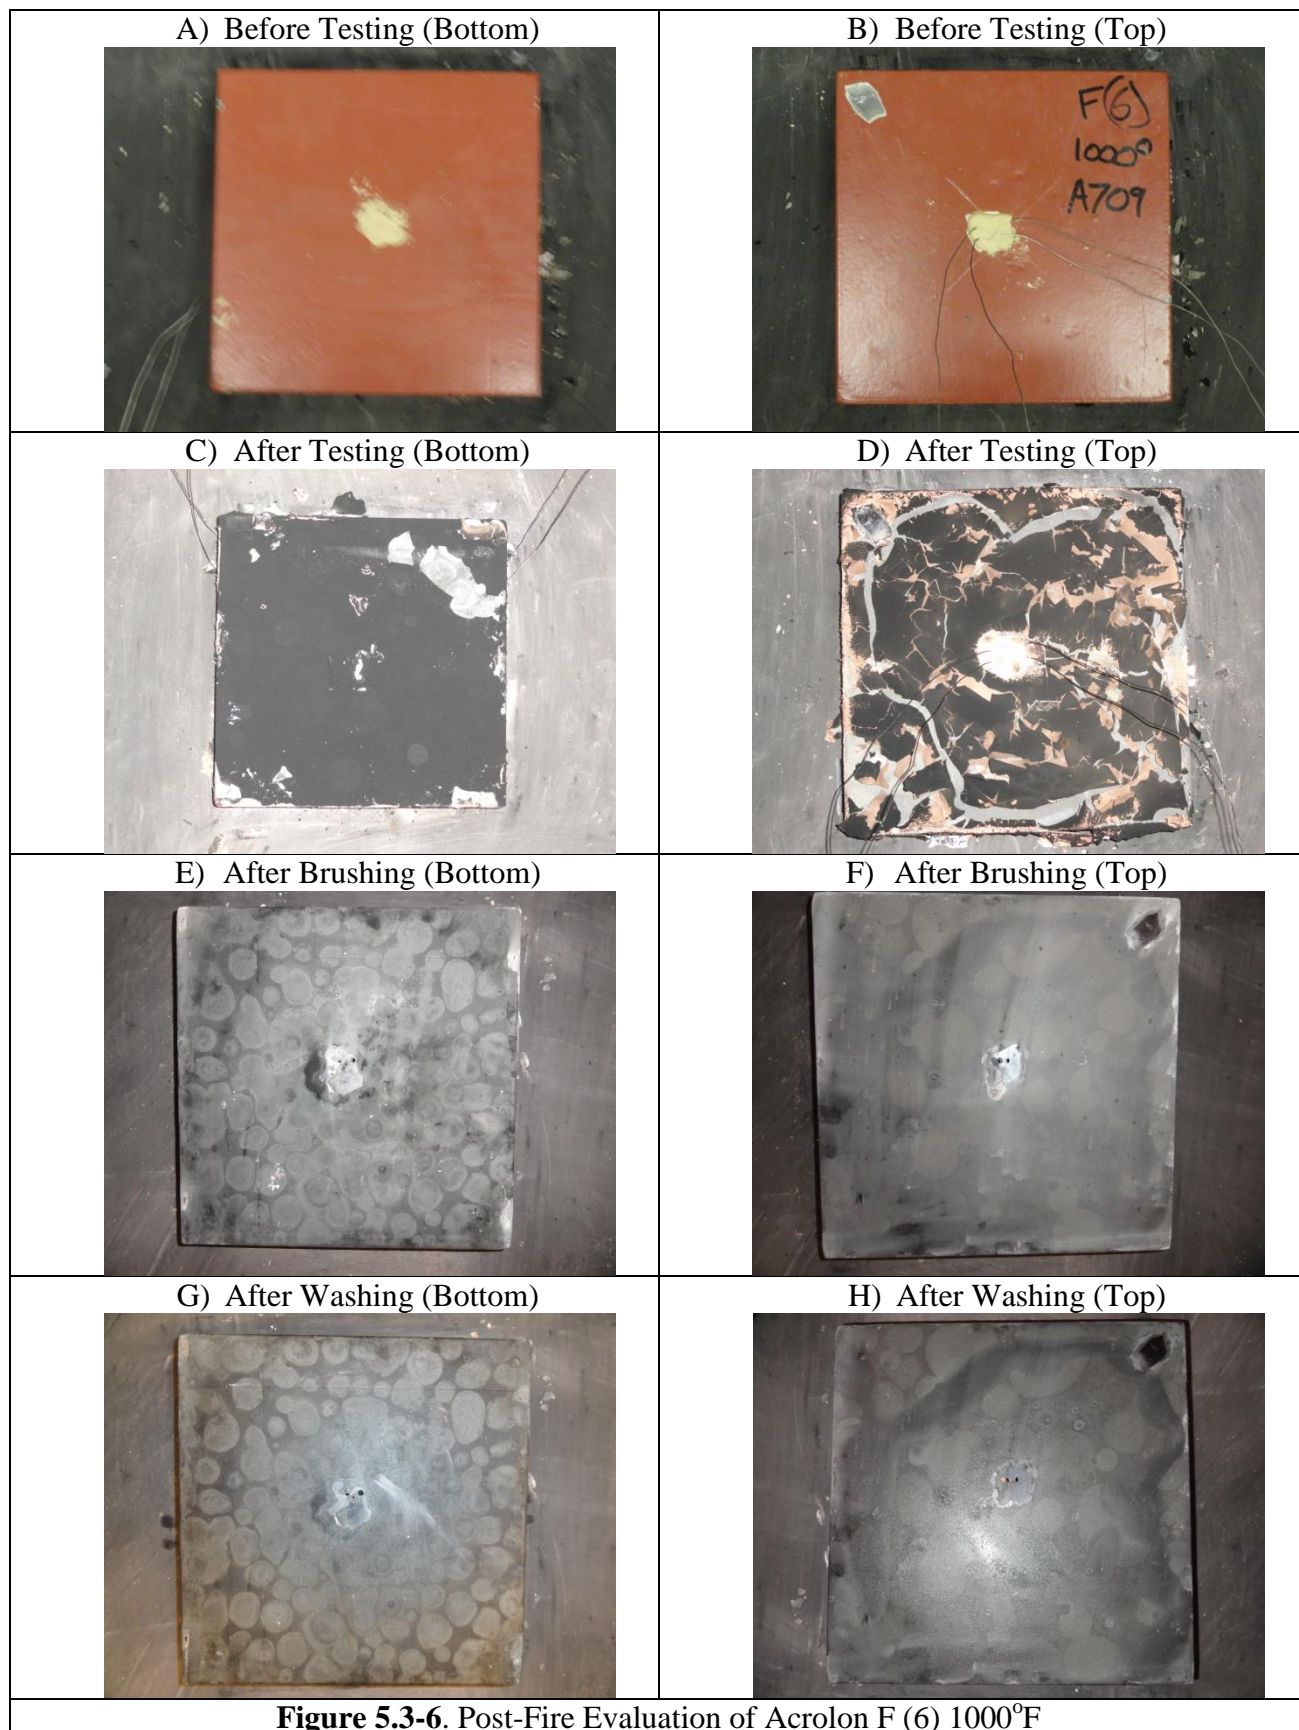
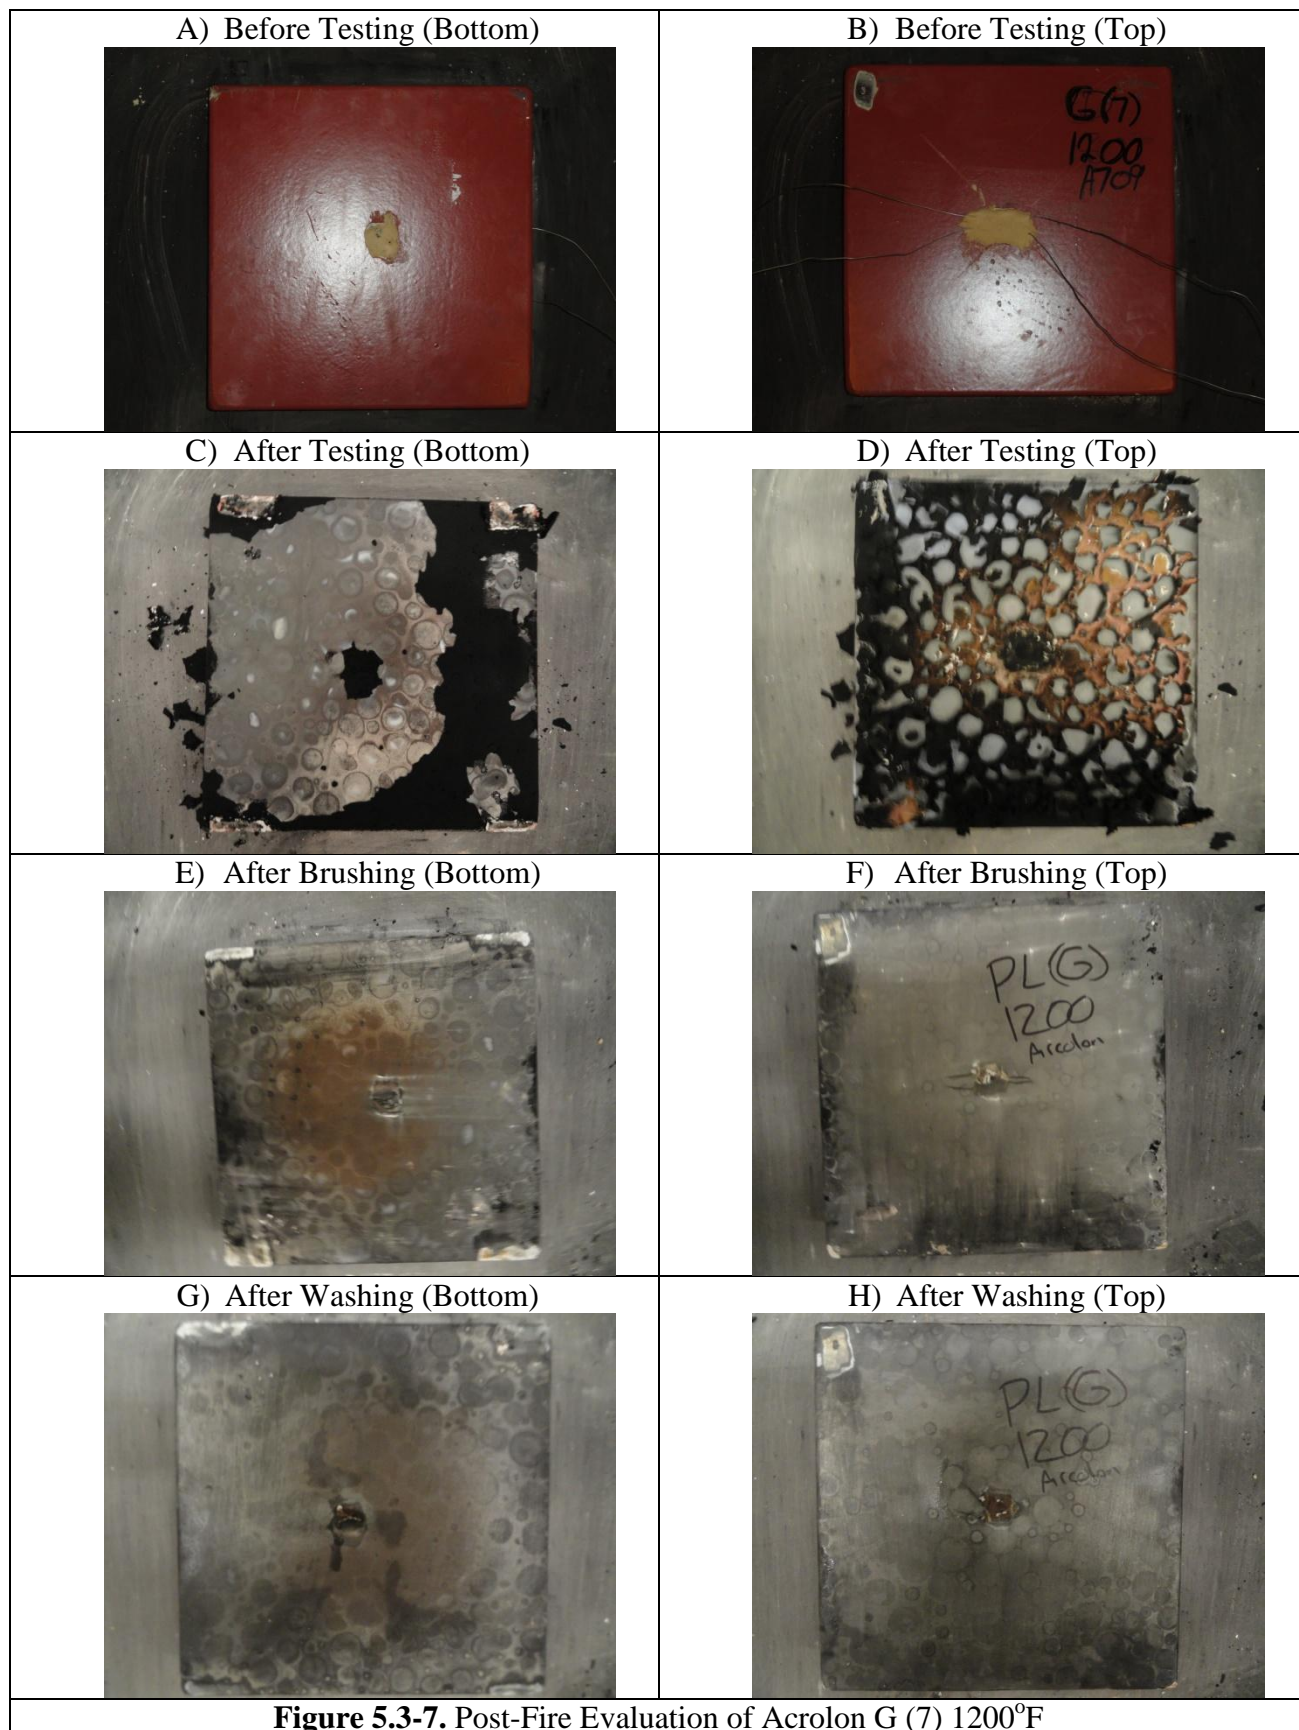
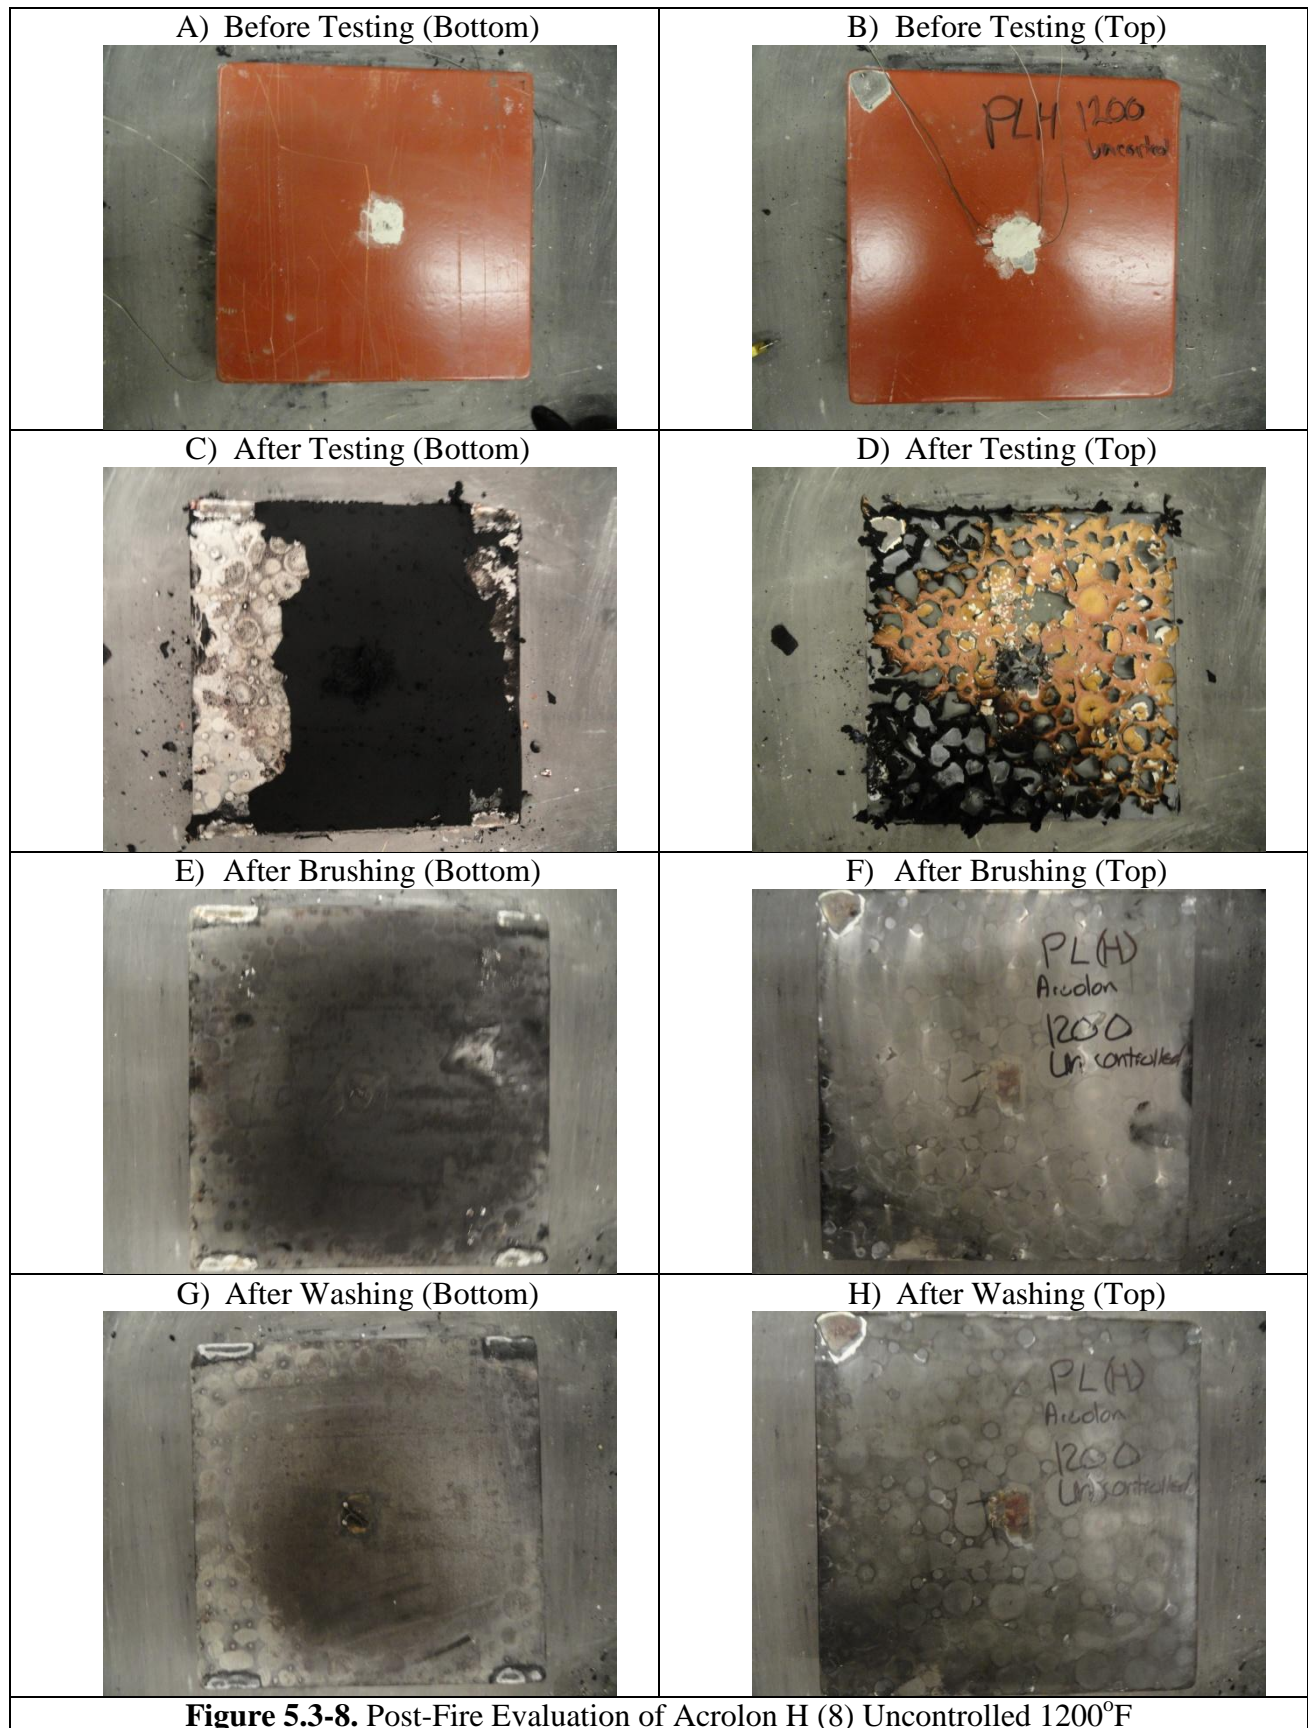
Figures 5.3-1 to 5.3-8 show photographs of the post-fire evaluation of the plate specimens (Part 3) identified in Table 4.2-1 and listed below. These include photographs taken as described in Section 4.4.

- Controlled fire exposures producing steel surface temperatures of 800 °F caused bubbles in the paint surfaces of the decommissioned bridge plates (Parts 1 and 2) and Acrolon coated (Part 3) plates. In some cases these bubbles had popped but the general shape (outline) remained. After brushing the plates, the spots where bubbles were located could still be seen on the surfaces of the plates. Controlled fire exposures producing surface temperatures of 800 °F caused cracking in the paint surfaces of the Carbothane coated plates. A clean gray surface was revealed after brushing and washing the fire exposed plates. It should also be noted that the old paint coatings (on decommissioned bridges) burned off completely, whereas the primer coat of the three coat systems remained intact.

- For Acrolon coated plates (Part 3) subjected to controlled fire exposures producing steel surface temperatures of 1000 °F, all the bubbles that had formed in the paint surface had popped and cracked to form a desiccated pattern over the steel surface. Even after washing, the spots where the bubbles existed in the paint system could still be seen on the steel surfaces. The Carbothane coated plates (Part 4) remained cracked and continue to reveal the clean gray surface after brushing and washing. It should also be noted that the old paint coatings (on decommissioned bridges) burned off completely, whereas the primer coat of the three coat systems remained intact.
