Effects of Fire Damage on the Structural Properties of Steel Bridge Elements

FINAL REPORT

April 30, 2011

University of Pittsburgh

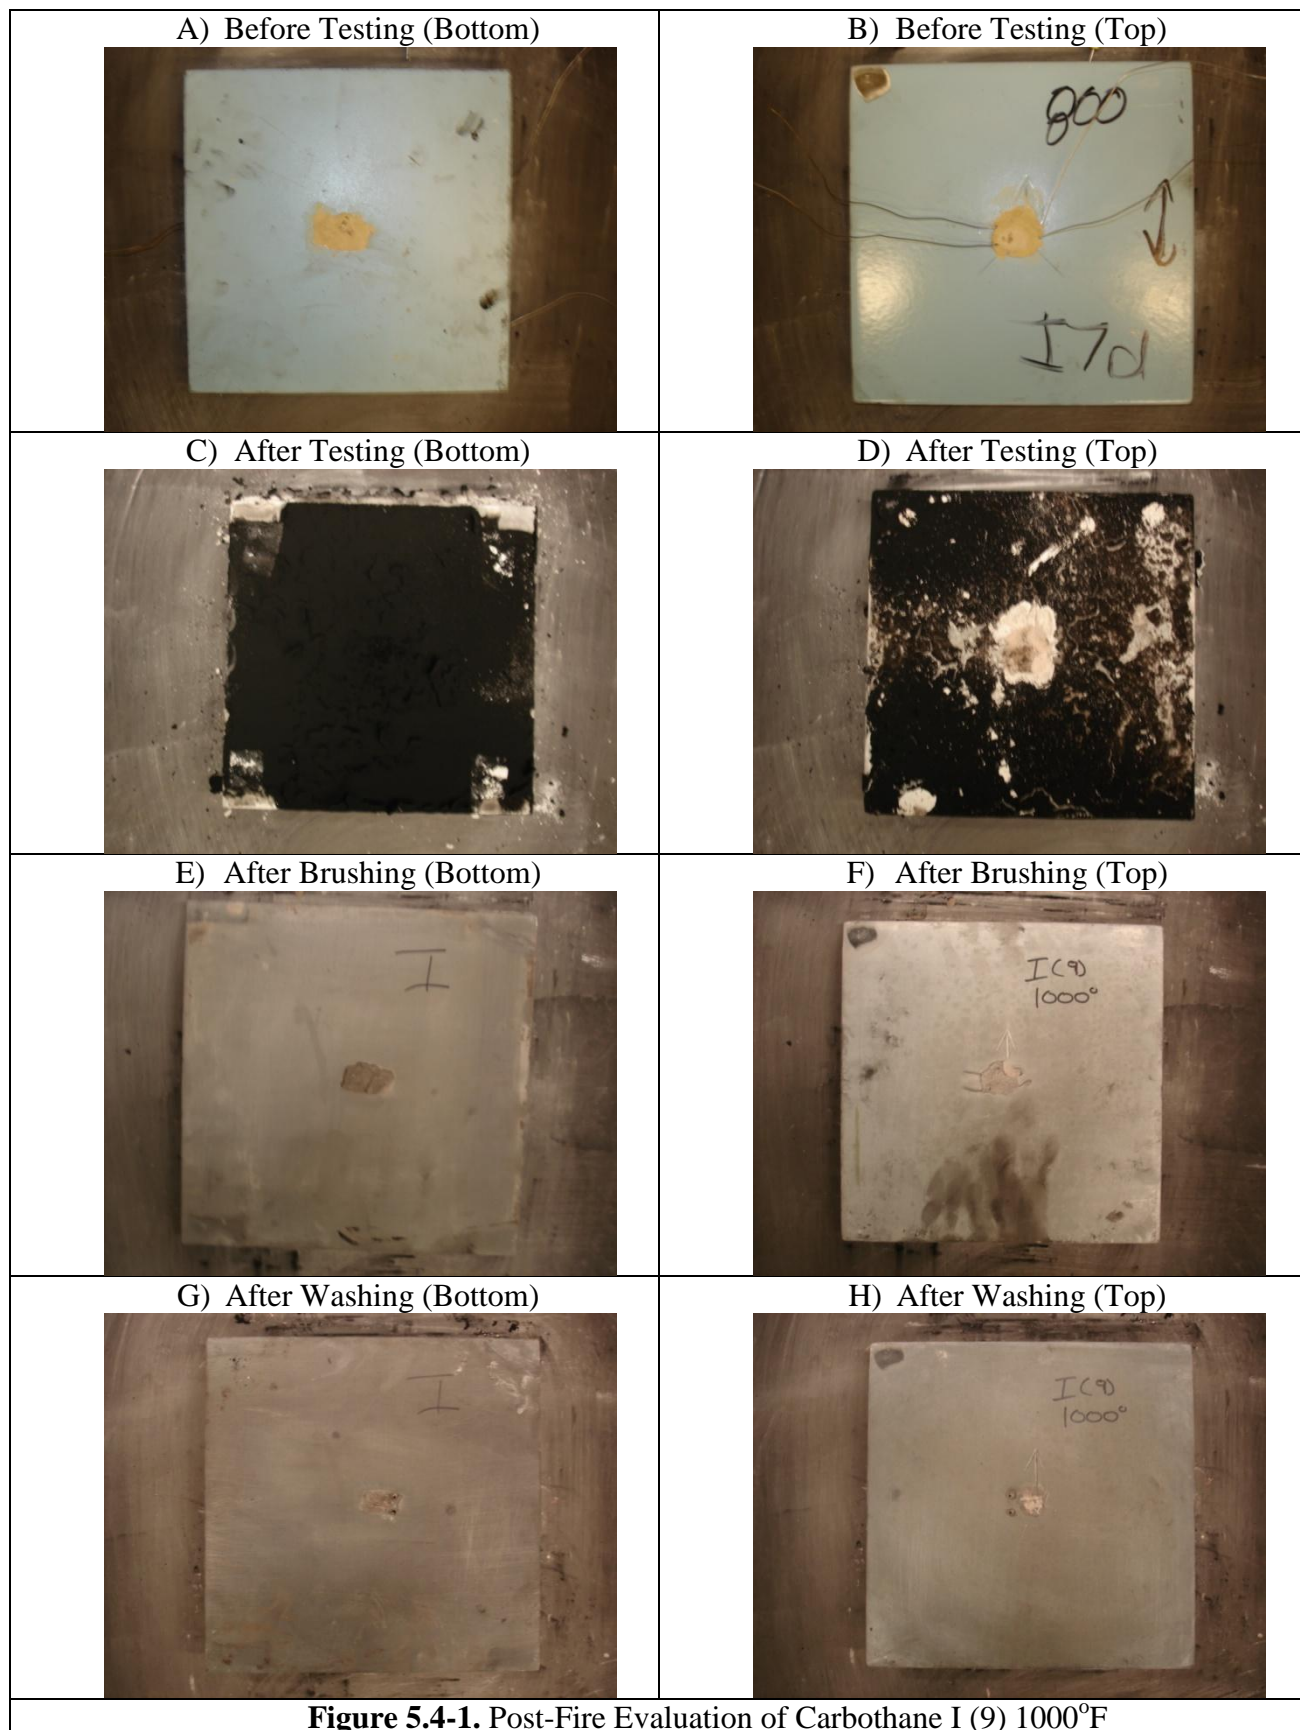
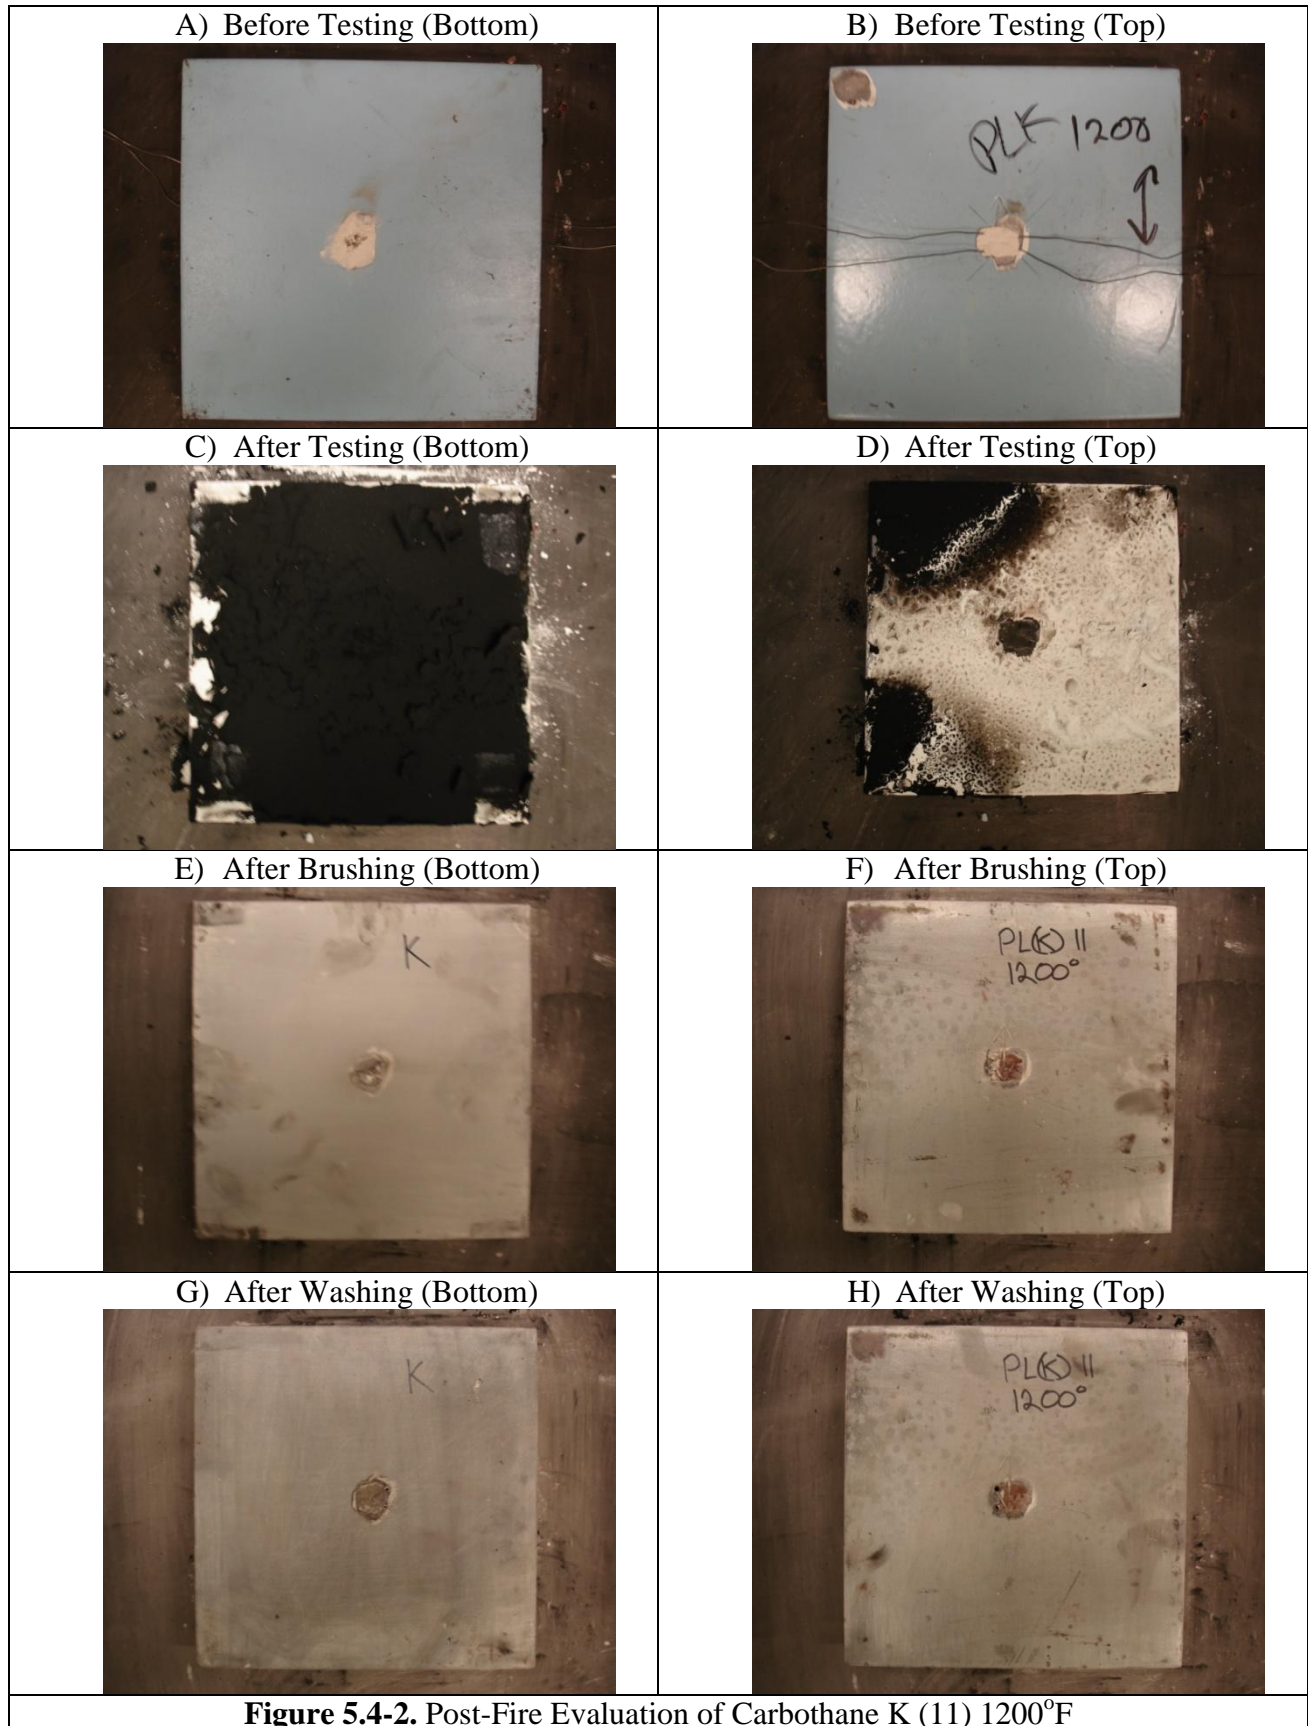
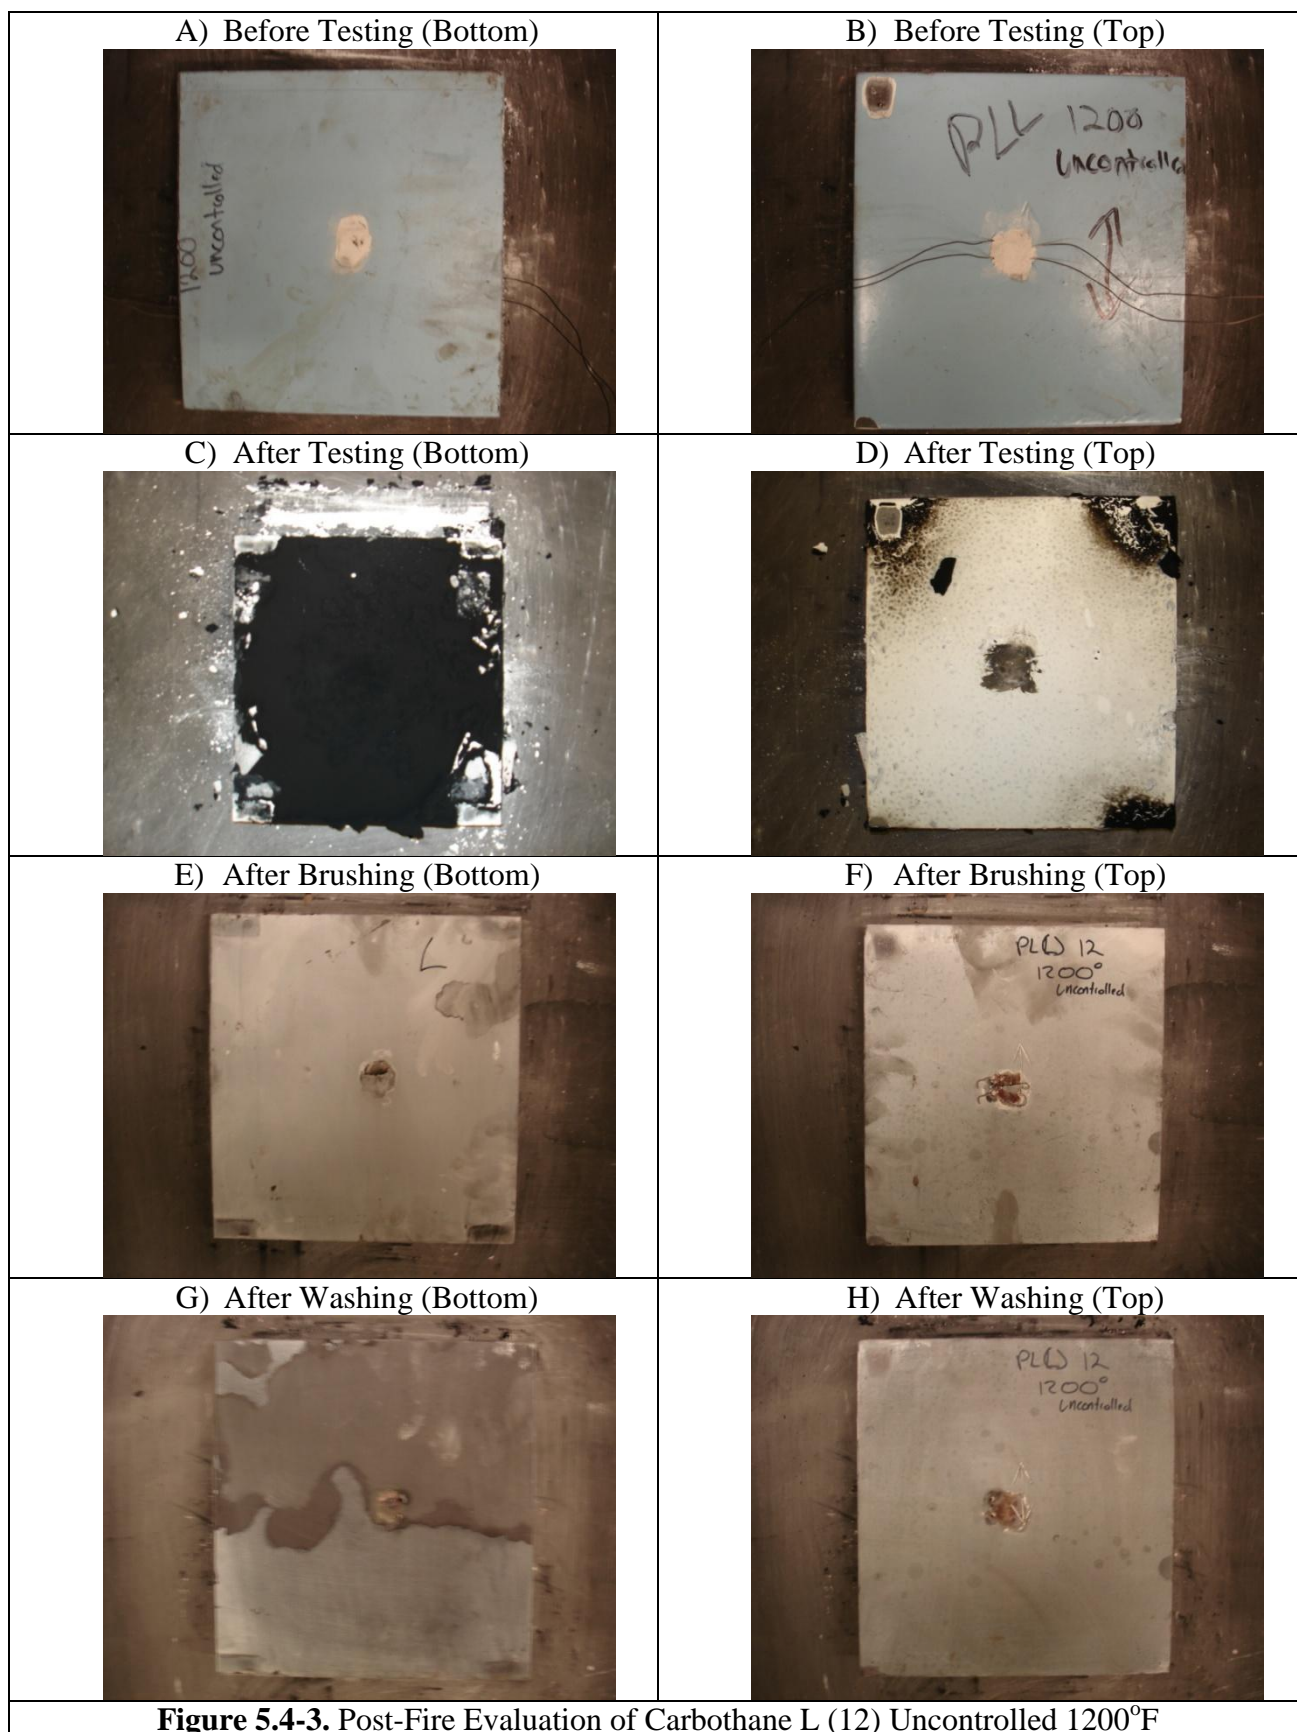
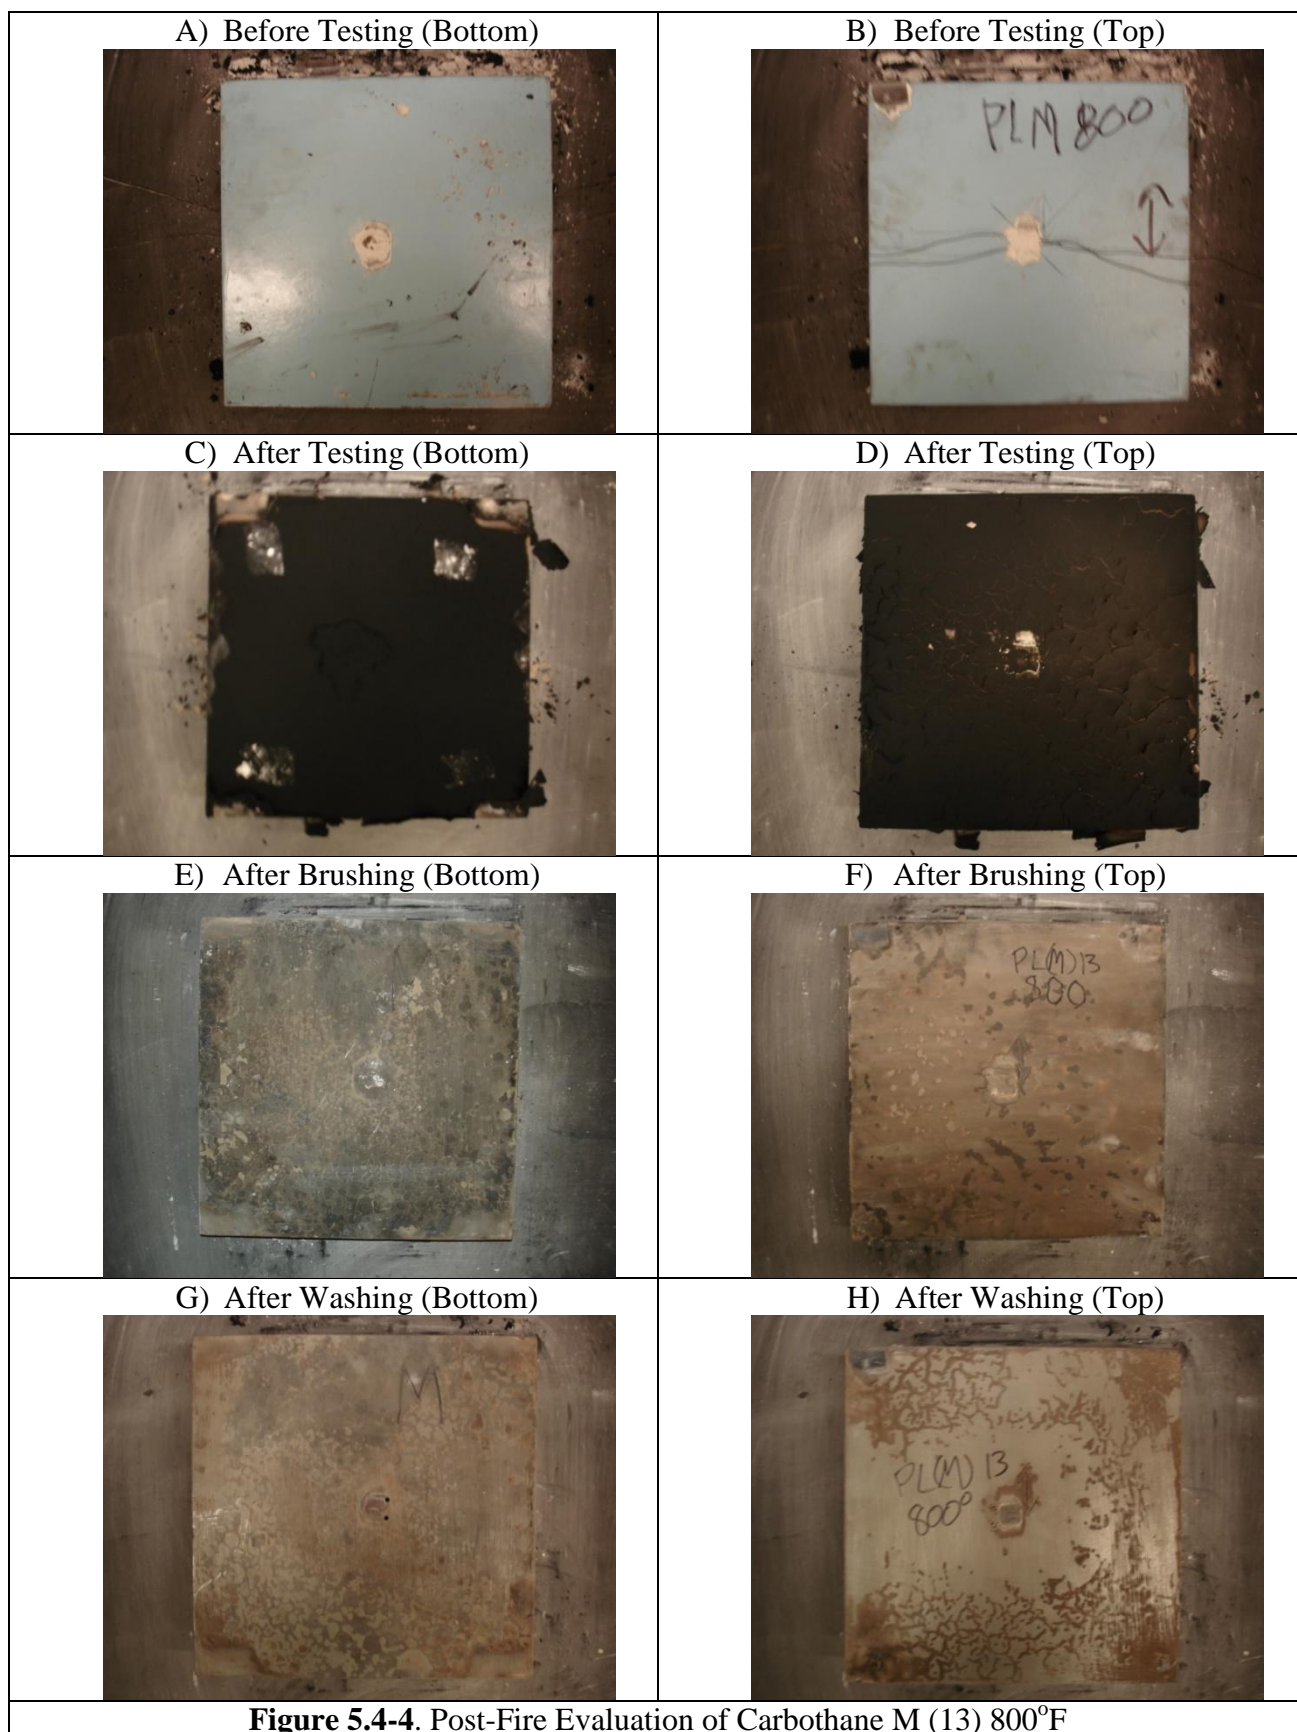
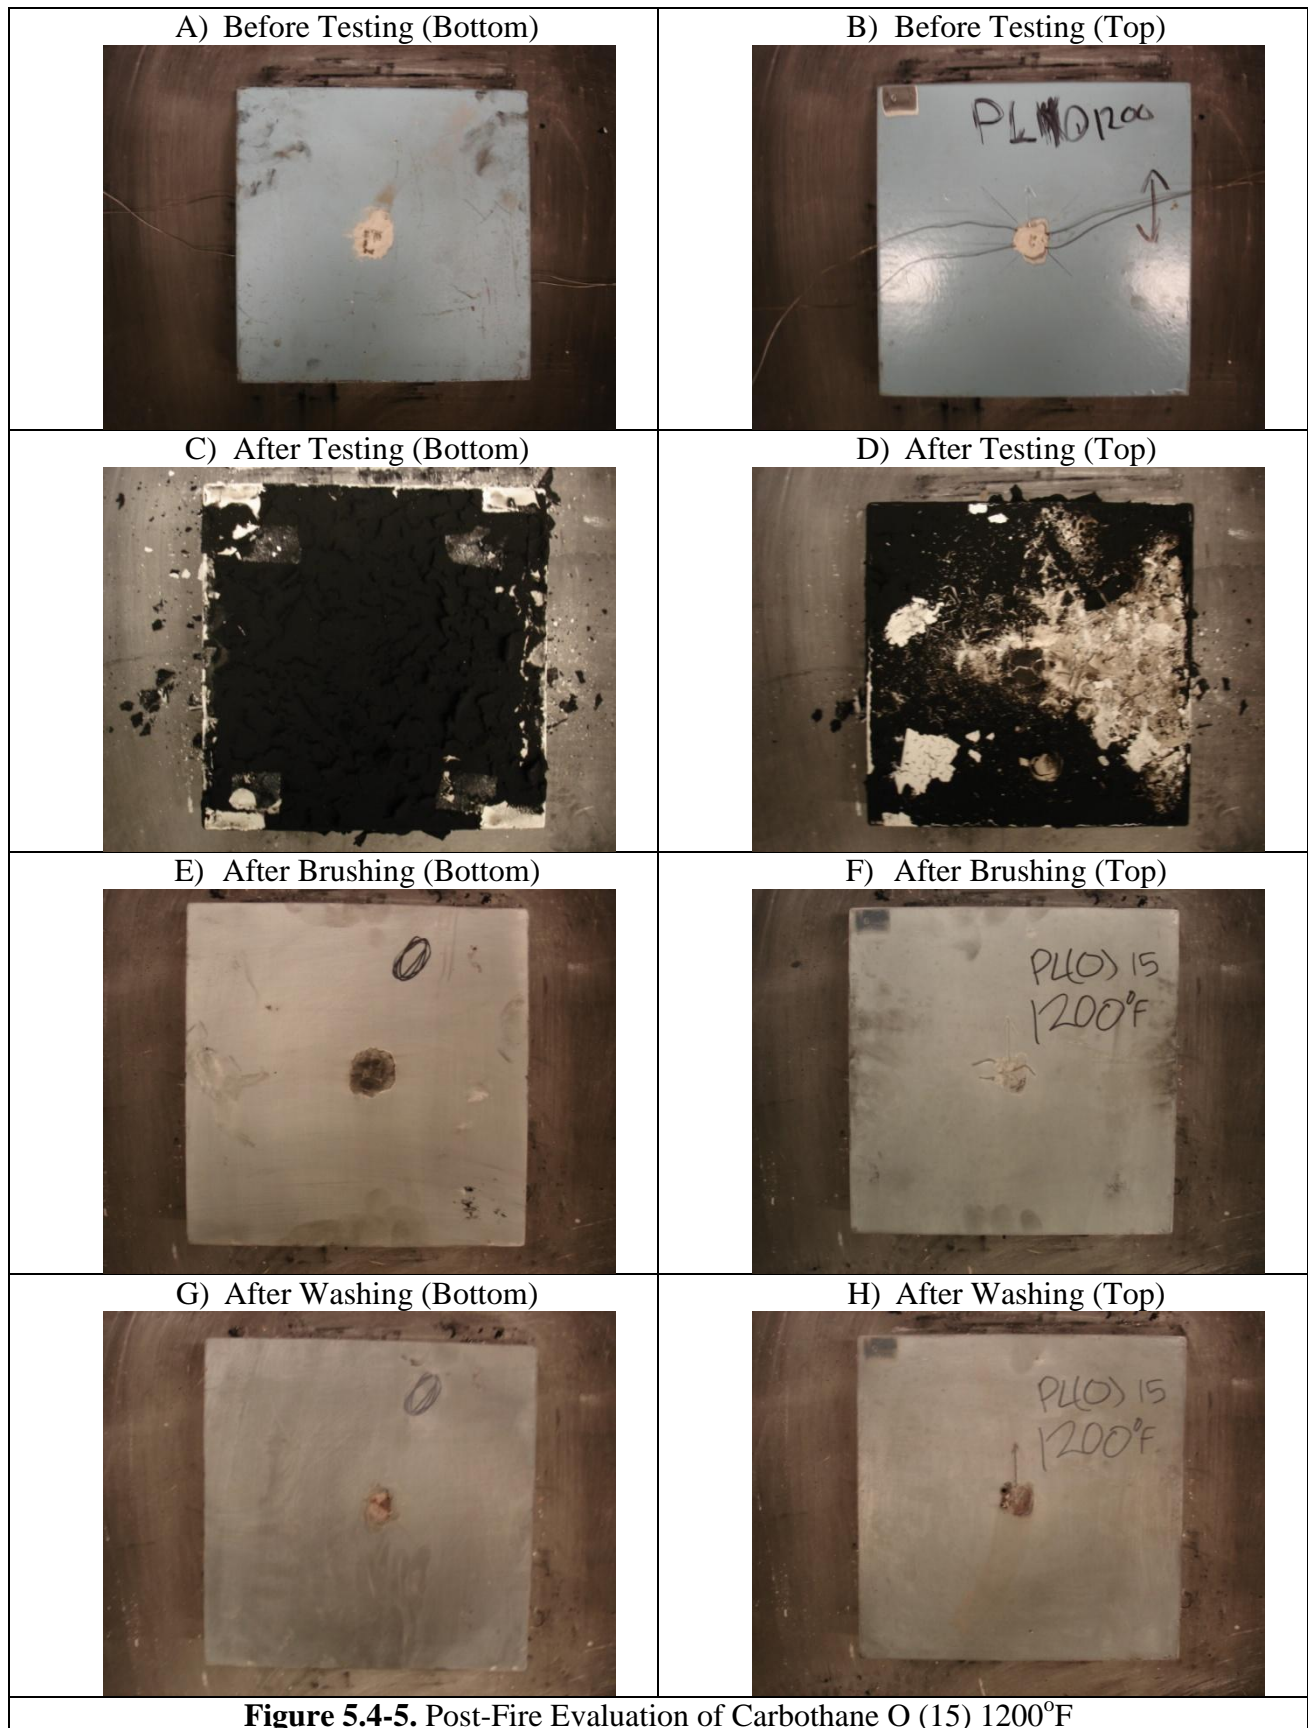
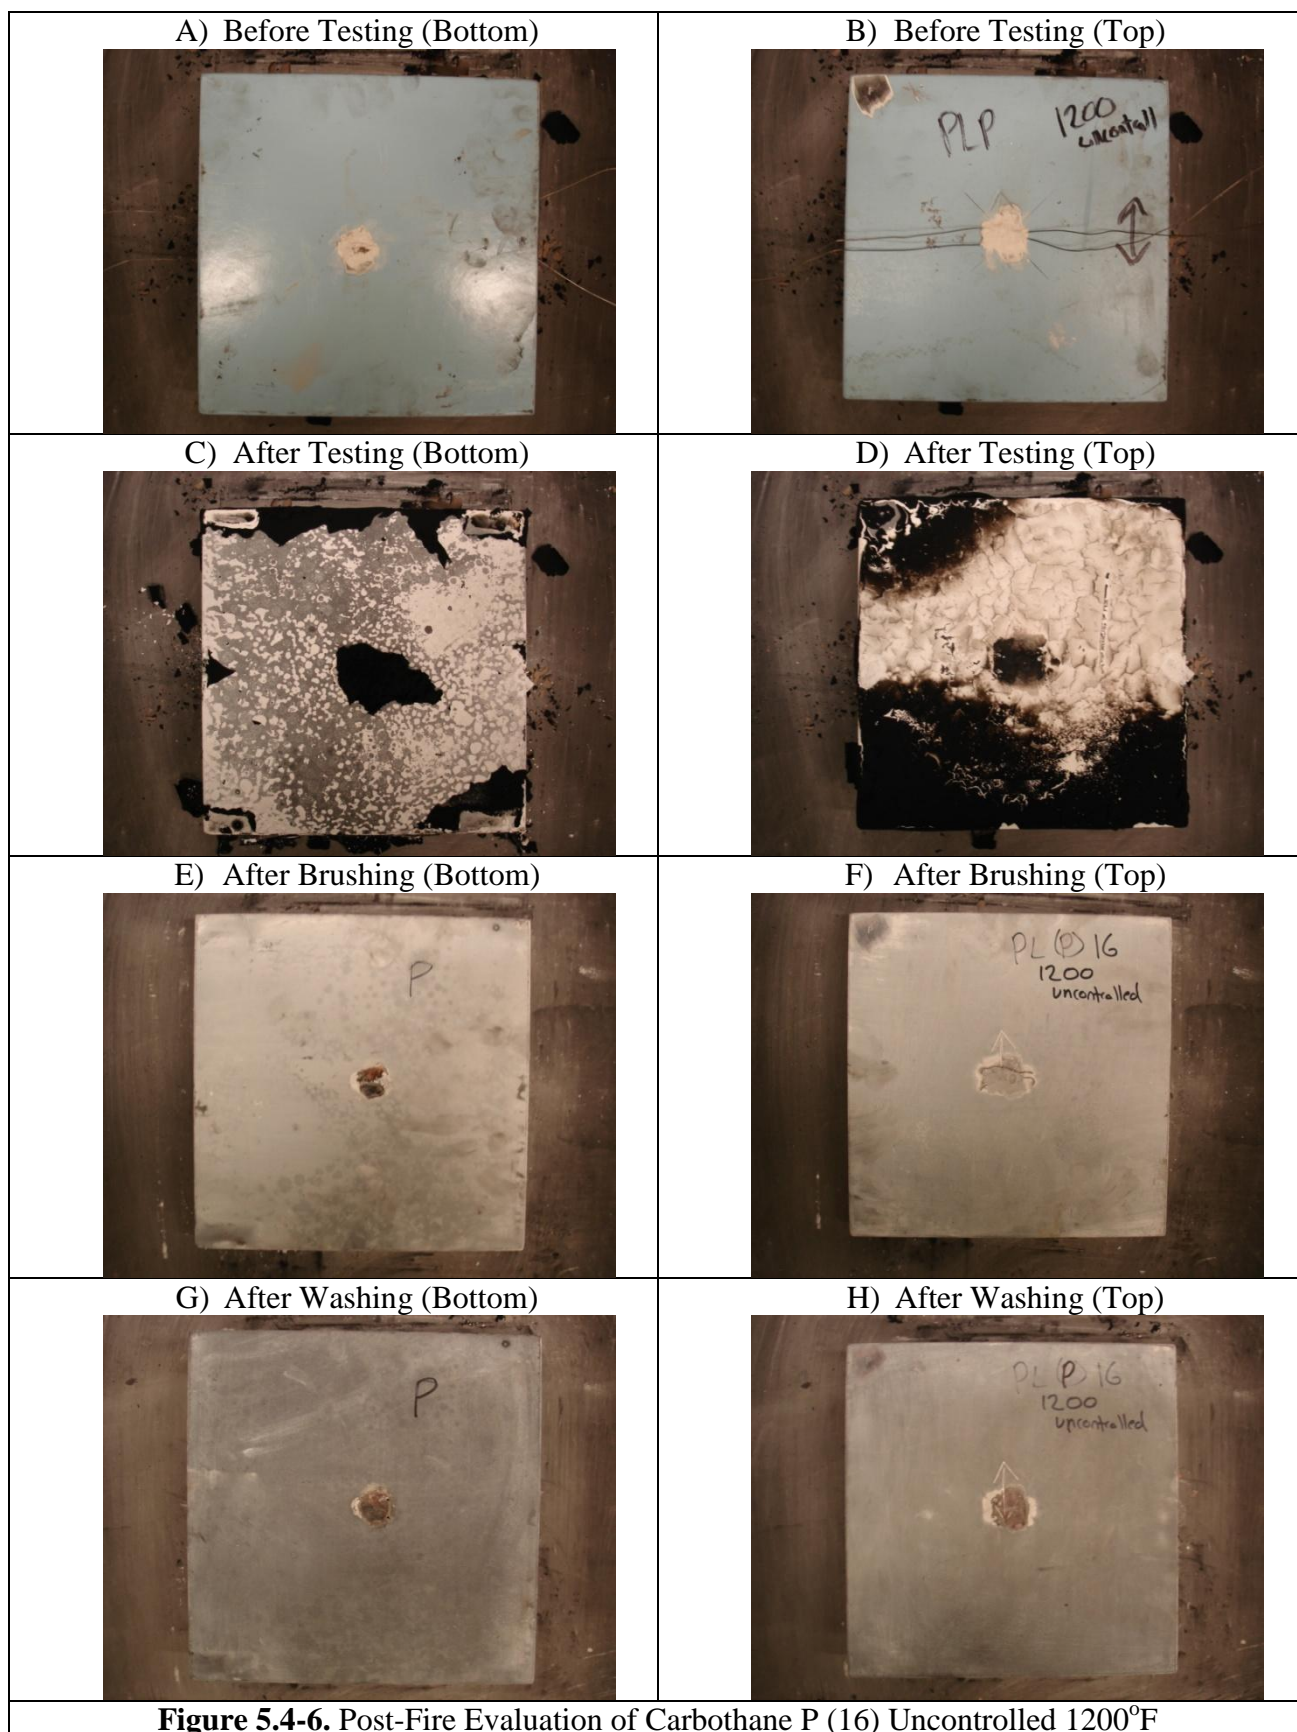
Figures 5.4-1 to 5.4-6 show photographs of the post-fire evaluation of the plate specimens (Part 4) identified in Table 4.2-1 and listed below. These include photographs taken as described in Section 4.4.
